Appendix 16-1 - Road Safety Audit

Stage 1 Road Safety Audit

Cloghercor Wind Farm, Co Donegal

February 2023

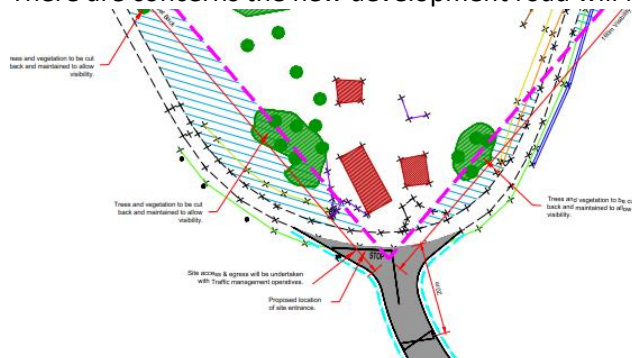
3.2.4 Site Access 1 – Gradient

Problem: The lands for the future development access junction are elevated above the existing road. There are concerns the new development road will fall steeply towards the existing road.

Hazard: Vehicles departing the development may overshoot the junction.

Recommendation: Ensure a suitable gradient dwell area is provided.

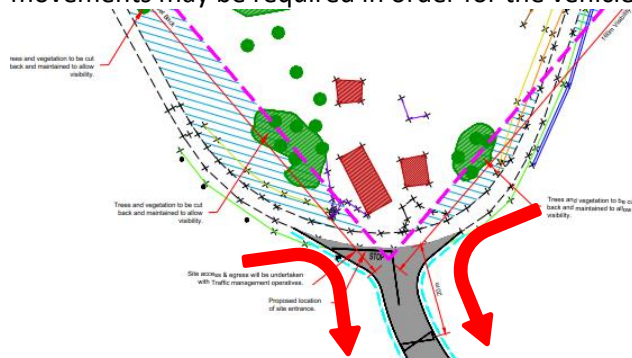
3.2.5 Site Access 1 – Swept Path

Problem: The audit team have been advised that turbine delivery will be via Access Location 1 only. The junction geometry appears tight for passage of long vehicles. Multiple forward / reverse movements may be required in order for the vehicle to access the new road.

Hazard: Impact with following traffic may result.

Recommendation: Ensure a suitable junction geometry is provide for access of delivery vehicles.

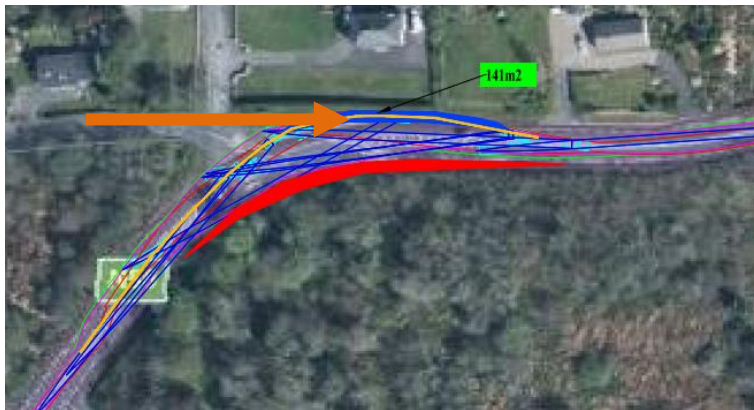
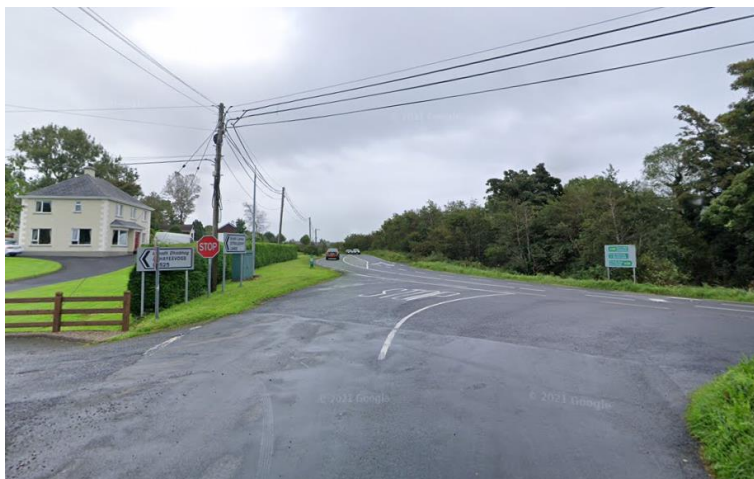
3.3.1 Road Widening Fig 16.8

Problem: The proposed widening on the National Road is in the area of the L5465 local grade road. At present the grassed verge assists in forcing vehicles exiting the location road to align right angles with the National Road.

Hazard: The removal of this verge / replacement with hardstanding may result in overshoot type collisions with National Road traffic.

Recommendation: Ensure adequate physical measures are retained / installed to ensure local road traffic both yield to the national Road users and also at a suitable angle, where approaching vehicles from both direction can be observed with ease.

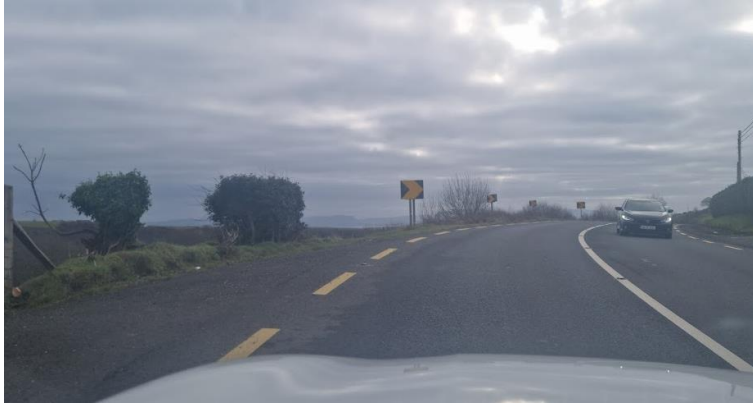
3.3.2 Road Widening – Fig 16.9

Problem: The field level to the east of the proposed widening is substantially lower than the existing road level. The provision of road widening to this side of the road may result in the existing embankment being made steeper.

Hazard: Errant vehicles may overturn due to the steep embankment.

Recommendation: Ensure the embankment / fall is no greater than existing.

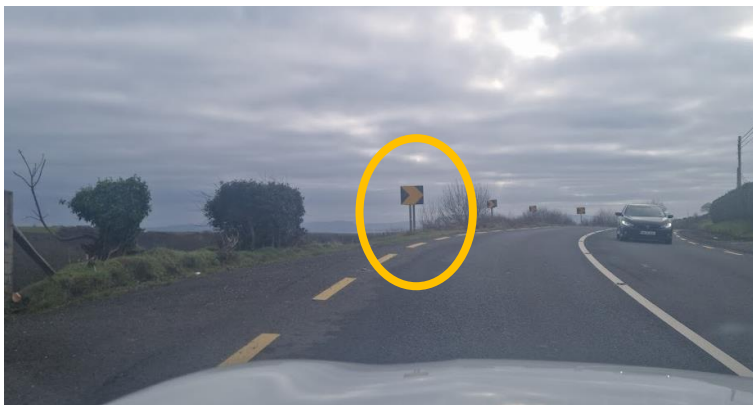
3.3.3 Road Widening Fig 16.9 – Signage

Problem: Existing chevron signs are located in the area of the proposed road widening. Removal / relocation of the chevron signs may lessen the impact of the sign to the motorist.

Hazard: Users may attempt to drive around the bend at excessive speed. Loss of control collisions may result.

Recommendation: Ensure suitable warning of the bend is provided to the road user at all times, even when component deliveries are scheduled.

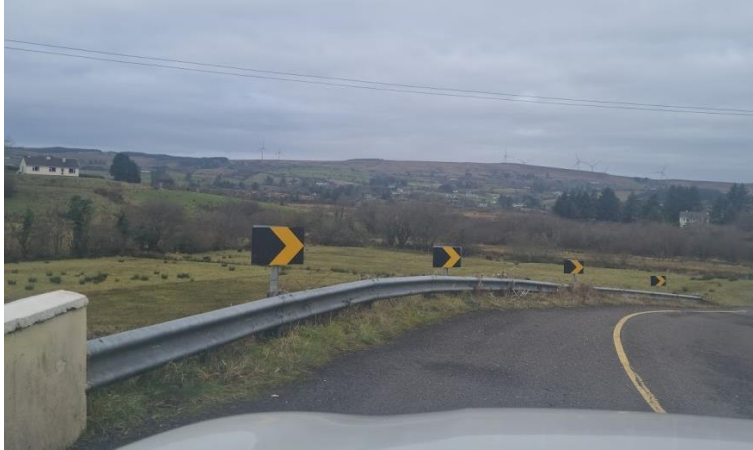
3.3.4 Road Widening Fig 16.15 - VRS

Problem: The lands to the west of the proposed road widening fall away from the road at a steep gradient. Currently the fall is protected by a vehicle restraint barrier. The barrier will need to be removed for passage of the turbine delivery vehicles.

Hazard: Errant motorist may traverse the road widening and overturn on the steep gradient.

Recommendation: Ensure suitable vehicle restraints are provided wherever the gradient is within the carriageway clear zone. Furthermore, ensure the anticipated angle of impact is suitable for the performance of the barrier.

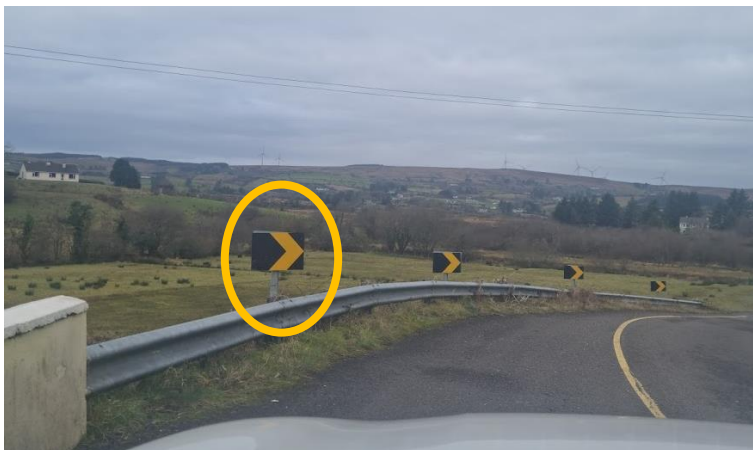
3.3.5 Road widening Fig 16.15 – Signage

Problem: Existing chevron signs are located in the area of the proposed road widening. Removal / relocation of the chevron signs may lessen the impact of the sign to the motorist.

Hazard: Users may attempt to drive around the bend at excessive speed. Loss of control collisions may result.

Recommendation: Ensure suitable warning of the bend is provided to the road user at all times, even when component deliveries are scheduled.

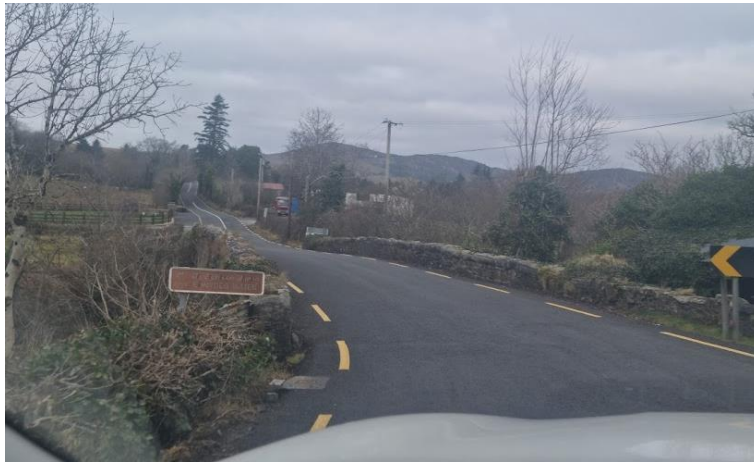
3.3.6 Road Widening – Fig 16.17

Problem: There is an existing humped back bridge with stone parapet walls in the area of the proposed road widening / body swing. There is concern that the delivery vehicle may impact with the parapet wall and cause structural damage.

Hazard: Future errant vehicles may impact with the damaged parapet and break through / enter the river.

Recommendation: Ensure no damage is caused to the parapet wall.

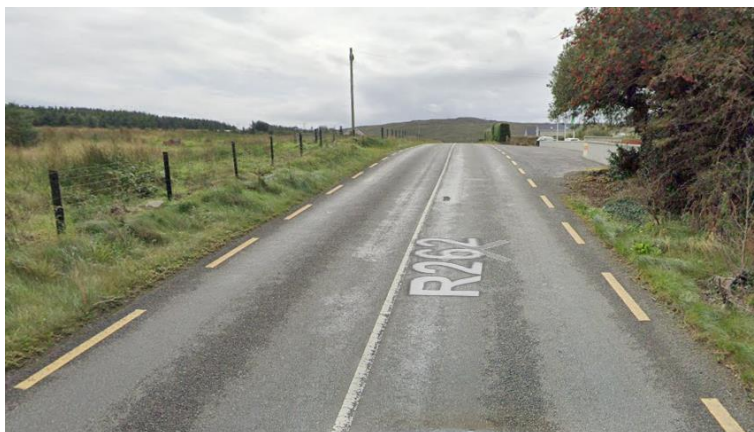
3.3.7 Set Down Area – Fig 16.22

Problem: The set down area is located just to the south of a crest curve on the Regional Road. Long and slow moving vehicles, in the process of crossing the Regional Road in order to access the set down area, may not be seen by southbound Regional Road traffic.

Hazard: Impact between the southbound public road user and the development vehicle may result.

Recommendation: Ensure the set-down area is provided where adequate forward visibility can be achieved.
