Owenreagh/Craignagapple Wind Farm

Environmental Statement- Technical
Appendix A9.1 Peat Slide Risk Assessment

06 September 2023

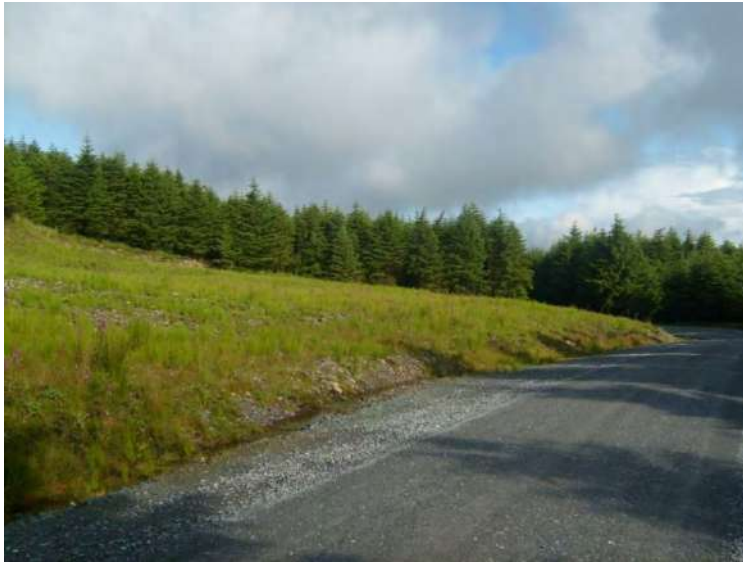
Photo 1 Good example of restored area filled with peat and sub soils

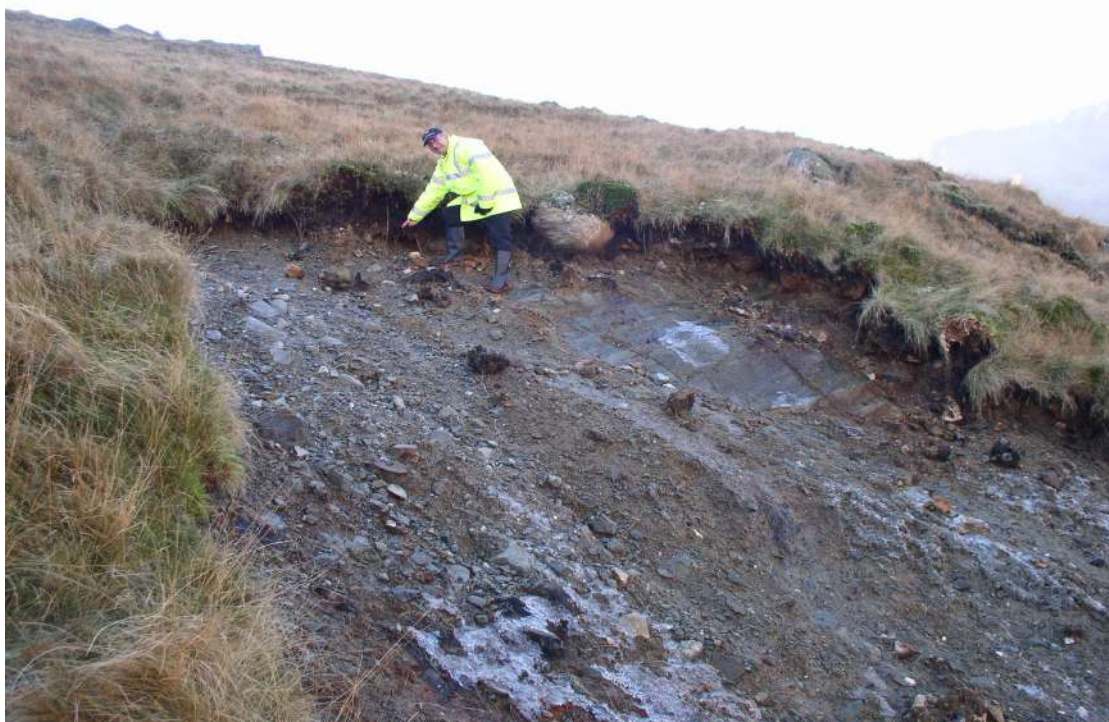
Fig. 2. Initiation point of a shallow peatslide on a rockhead of coarse gravel and smooth rock.
