Hornsea Project Four: Preliminary Environmental Information Report (PEIR)

Volume 6, Annex 3.1: Ecology - Extended Phase 1 Habitat Survey Report

A6.3.1
Version: A

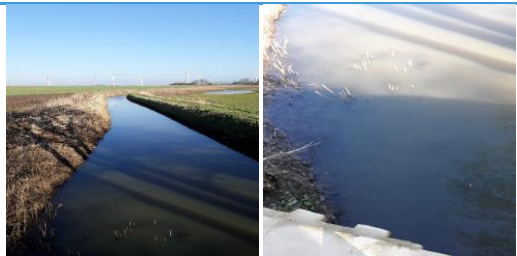
Target Note (TN) Reference	Description	British National Grid	Photograph Thumbnail
TN1	Wide dyke/beck with vertical grassy banks, recently trimmed. Common reed present, no in channel vegetation. Static flow, approximately 8-10m wide, silted with poor water quality. Potential water vole habitat Potential otter habitat	N: 456699.690876 E: 512410.169303

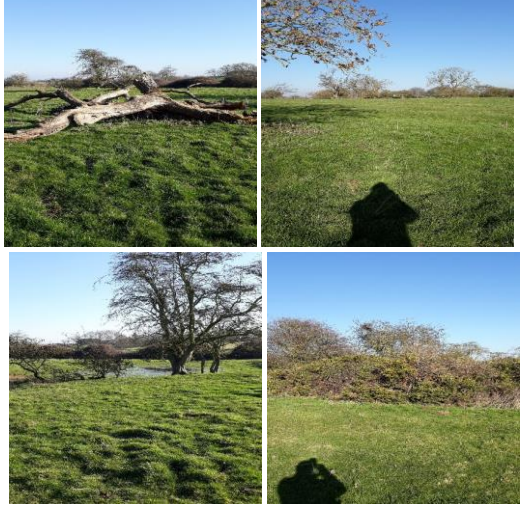
TN12	<p>Large, ivy clad sycamore with limited potential roost features (PRFs) visible from ground. Opportunistic roosting potential only.</p> <p>Low suitability for roosting bats.</p>	<p>N: 456619.072235 E: 511593.914512</p>	 
TN13	<p>Poor semi-improved grassland (JNCC: B6) Habitat consisting of ridge and furrow features throughout, large mature trees, fallen branches and dense scrub sections with gorse and bramble. Optimal reptile mosaic habitat with features for basking, foraging and hibernating.</p>	<p>N: 456613.462735 E: 511330.787742</p>

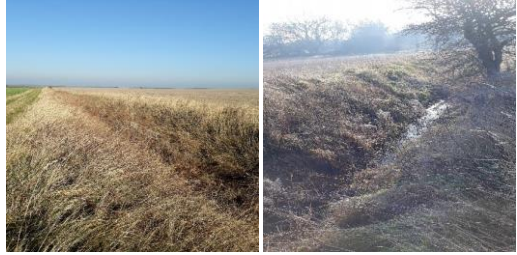
Target Note (TN) Reference	Description	British National Grid	Photograph Thumbnail
TN42	Narrow ditch with heavily vegetated grassy banks, partially dry, common reed present. Potential water vole habitat.	N: 456027.072821 E: 509716.957266

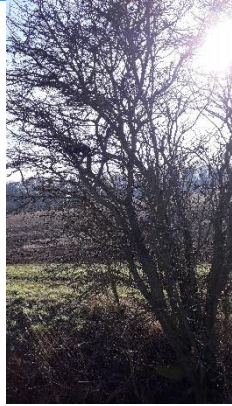
Target Note (TN) Reference	Description	British National Grid	Photograph Thumbnail
TN80	Hawthorn with bird nest.	N: 451976.864813 E: 506186.144706

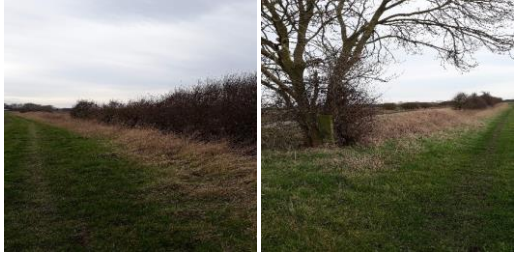
Target Note (TN) Reference	Description	British National Grid	Photograph Thumbnail
TN96	<p>Species poor defunct hedge (JNCC: J2.2.2) consisting of hawthorn, one young ash with negligible bat roost suitability. Large gaps with occasional hawthorn present.</p> <p>Low suitability for commuting and foraging bats.</p>	<p>N: 448942.533807 E: 504573.407232</p>

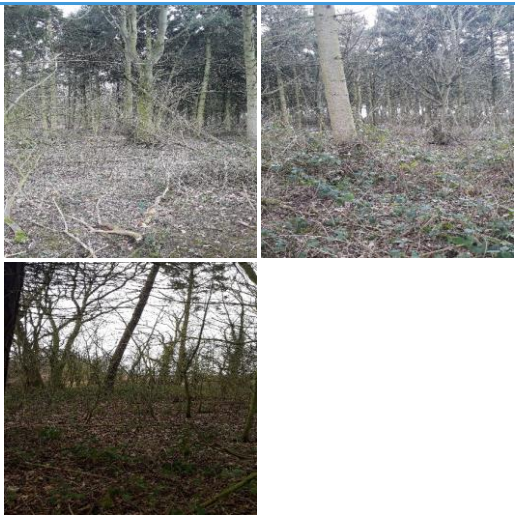
TN111	<p>Mixed plantation woodland (JNCC: A1.3.2) consisting of a mixture of pines, oak, sycamore, and ash. Undergrowth consisting of dense bramble in places.</p>	<p>N: 445440.273961 E: 500648.724</p>

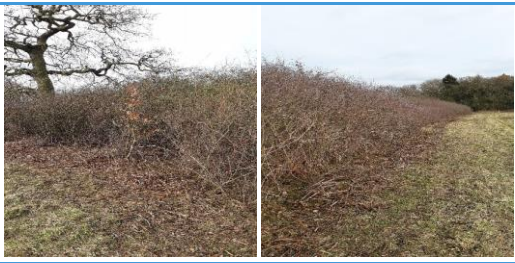
TN112	<p>Scrub (JNCC: A2.1) consisting of dense bramble and hawthorn along stream banks with scattered trees.</p>	<p>N: 445425.170261 E: 500372.28914</p>

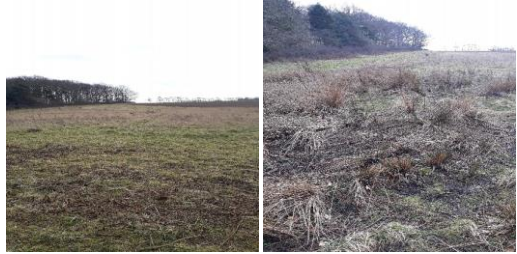
Target Note (TN) Reference	Description	British National Grid	Photograph Thumbnail
TN113	Poor semi-improved grassland (JNCC: B6) Small area of grassland adjacent to woodland and arable field. Relatively short sward, broad leaved dock and nettle present and small wet patches with juncus spp.	N: 445419.883684 E: 500487.354237

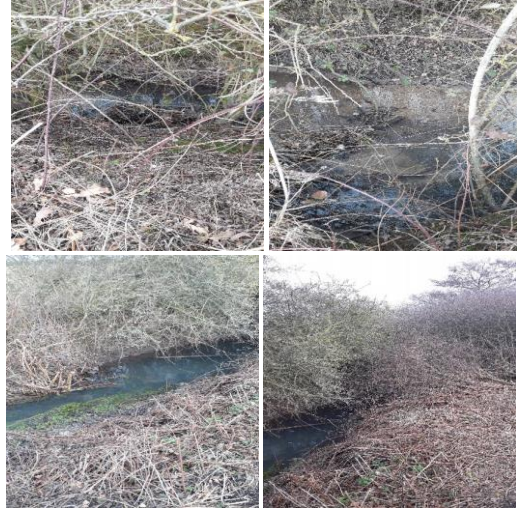
TN114	Stream, approximately 3m wide, slow flowing, shallow banks in places with open tree root systems, bed consisting of sandy gravel, surrounding habitat dense scrub with scattered semi mature trees. Potential water vole habitat. Potential otter habitat Moderate suitability for commuting and foraging bats.	N: 445418.699427 E: 500377.380102

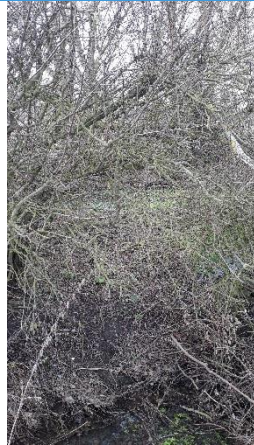
Target Note (TN) Reference	Description	British National Grid	Photograph Thumbnail
	Low suitability for roosting bats. Moderate suitability for commuting and foraging bats.		
TN117	Arable field (JNCC: J1.1) – ploughed field.	N: 445228.903272 E: 500377.282307	n/a.
TN118	Species poor intact hedge (JNCC: J2.1.2) Consisting of hawthorn and ivy, recently trimmed. Low suitability for commuting and foraging bats.	N: 445154.231371 E: 500241.432517	 
TN119	Small ephemeral pond, potentially flooded/fed from field drain, surrounded by young ash and oak trees.	N: 445115.208295 E: 500247.764661

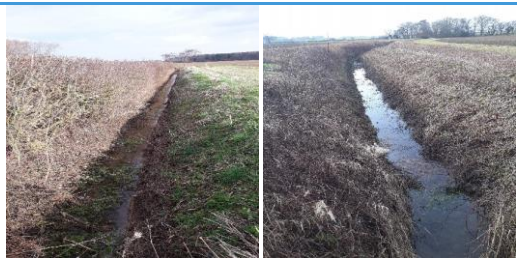
TN120	Ditch with steep sides, some sections with in channel vegetation, water cress, stagnant water c 15cm depth. Limited backside vegetation present as recently cleared, bramble, nettle, common hogweed and grasses present. Potential water vole habitat.	N: 445068.242506 E: 500261.779285

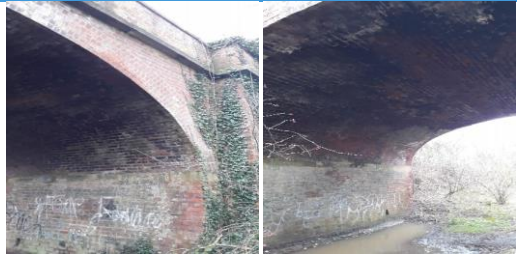
Target Note (TN) Reference	Description	British National Grid	Photograph Thumbnail
TN134	Arable field (JNCC: J1.1) – winter cover.	N: 442496.376472 E: 500411.435603	n/a.
TN135	Bridge with some ivy cover, no visible cracks or holes in the brickwork. Negligible suitability for roosting bats.	N: 442399.848484 E: 500257.843868

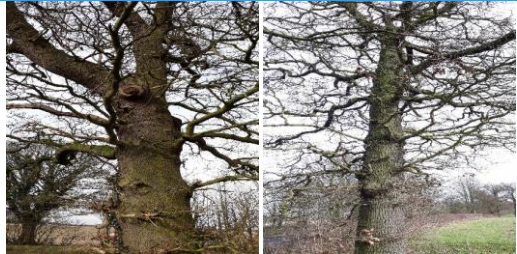
TN160	Two large mature oak with limited visible PRFs. Low suitability for roosting bats.	N: 439675.667831 E: 500498.092364

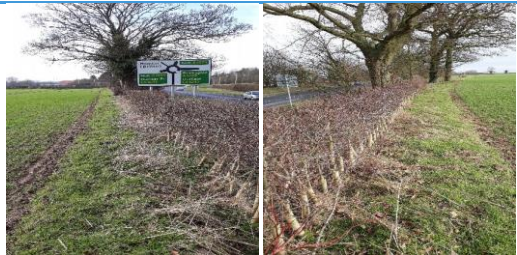
TN162	Species poor intact hedge (JNCC: J2.1.2) consisting of sections of newly planted hawthorn, blackthorn and bird cherry. Low suitability for commuting and foraging bats.	N: 439669.713052 E: 500483.394149

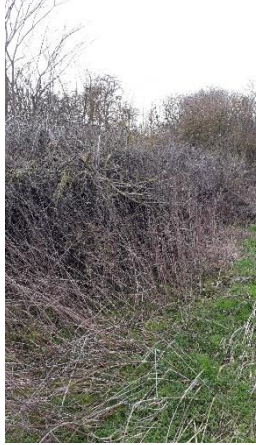
TN169	Large pile of vegetated woody debris, within hedge with wide grassy margins. Reptile hibernation feature connected to foraging habitat.	N: 439455.382035 E: 500380.090743

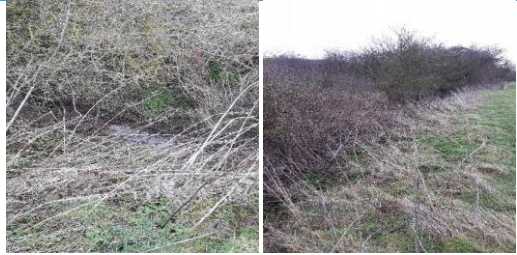
Target Note (TN) Reference	Description	British National Grid	Photograph Thumbnail
TN196	<p>Steep sided ditch/stream with low levels of running water. Heavily vegetated banks, tree lined, dense bramble in sections, difficult to access.</p> <p>Potential water vole habitat.</p>	<p>N: 437314.572149 E: 501005.229456</p>

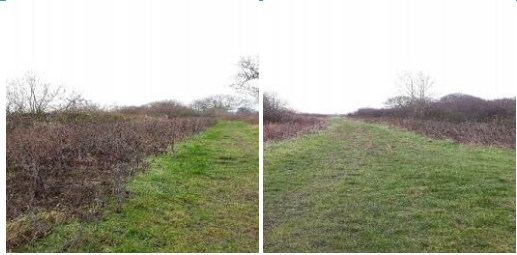
Target Note (TN) Reference	Description	British National Grid	Photograph Thumbnail
TN201	<p>Species poor intact hedge (JNCC: J2.1.2) consisting of hawthorn, hazel, bramble, nettle and broad leaved dock.</p> <p>Moderate suitability for commuting and foraging bats.</p>	<p>N: 436779.965191 E: 501219.016686</p>

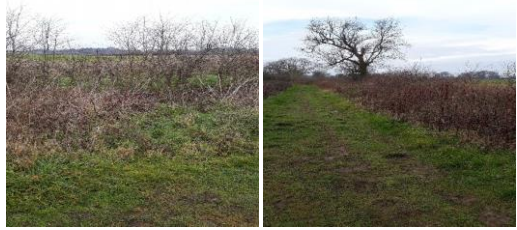
TN202	<p>Species poor intact hedge (JNCC: J2.1.2) consisting of mainly hawthorn with bramble and nettle, some sections newly planted.</p> <p>Moderate suitability for commuting and foraging bats.</p>	<p>N: 436776.363386 E: 501185.837815</p>

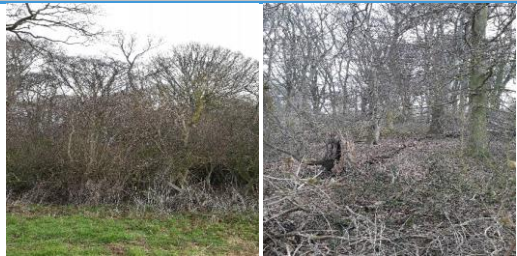
Target Note (TN) Reference	Description	British National Grid	Photograph Thumbnail
TN218	Species poor hedge with trees (JNCC: J2.3.2) consisting of hawthorn, sycamore and ash, connecting two areas of woodland and grassland. Moderate suitability for commuting and foraging bats.	N: 436197.213198 E: 502599.23307	
TN219	Semi-natural broadleaved woodland (JNCC: A1.1.1) consisting of ash, oak, hawthorn and bramble.	N: 436179.901872 E: 501466.353683

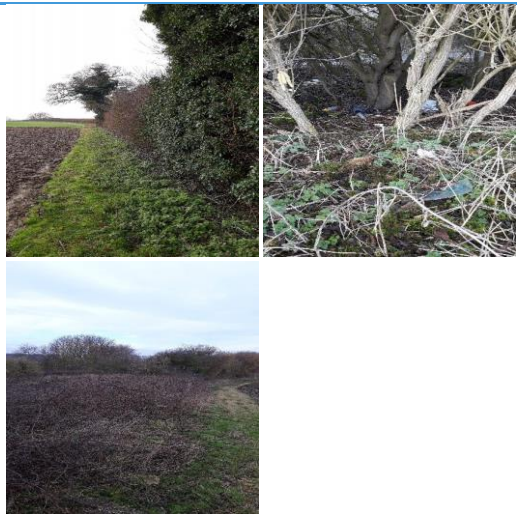
TN220	Arable field (JNCC: J1.1) – winter cover.	N: 436138.38043 E: 503248.605313	n/a.
TN221	Species rich hedge with trees (JNCC: J2.3.1) consisting of hazel, hawthorn, willow, ivy, bramble and field maple. Rubbish present in sections with road layby. Moderate suitability for commuting and foraging bats.	N: 436123.238135 E: 501244.185596

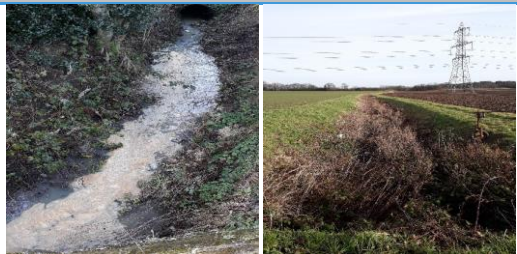
TN230	Group of 4 mature, possibly veteran, oak trees within semi improved grassland. high trunk density with cracks and holes. High suitability for roosting bats.	N: 435963.940058 E: 502835.610364	
TN231	Area of hardstanding and gravel with soil heaps and rubbish, offering potential reptile hibernacula.	N: 435931.165379 E: 503294.147642	
TN232	Potentially polluted ditch, silt and foam present. Some sections fast flowing, culverted, partly vegetated. Potential water vole habitat.	N: 435915.167654 E: 503335.405812

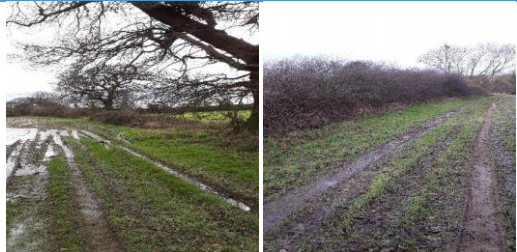
TN281	Species poor intact hedge (JNCC: J2.1.2) consisting of hawthorn, recently trimmed. Moderate suitability for commuting and foraging bats.	N: 435236.354833 E: 502619.942468	
TN282	Species poor hedge with trees (JNCC: J2.3.2) consisting of hawthorn and oak. Fenced in places with some gaps and sections of just bramble. Moderate suitability for commuting and foraging bats.	N: 435232.777898 E: 503245.144462

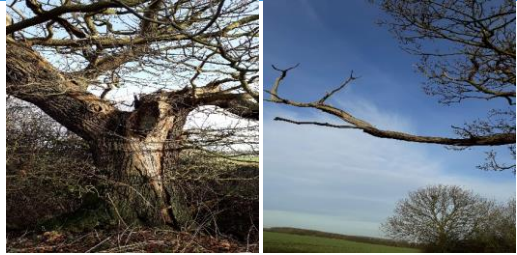
Target Note (TN) Reference	Description	British National Grid	Photograph Thumbnail
TN321	Dead oak with multiple cracks, holes and dead branches. High suitability for roosting bats.	N: 434967.727661 E: 504168.265723

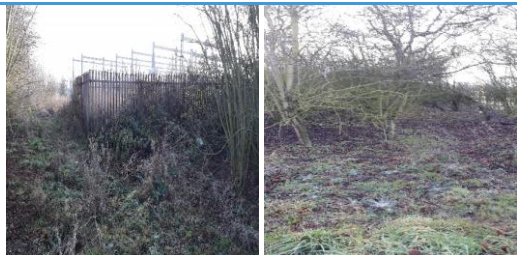
TN324	Pond (pond reference – A71).	N: 434959.013794 E: 503608.396923	
TN325	Scrub (JNCC: A2.1) – small area of scrub between hedge, arable field and substation, includes access road for existing substation.	N: 434958.460241 E: 504331.021697

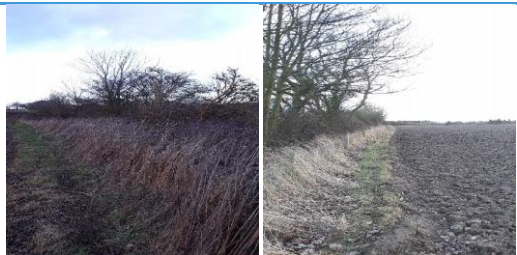
TN348	Pond (pond reference – A72).	N: 434810.58577 E: 503800.019908	
TN349	Arable field (JNCC: J1.1) – winter cover.	N: 434808.308396 E: 504296.081511	
TN350	Species poor hedge with trees (JNCC: J2.3.2) consisting of oak, ash, hawthorn, blackthorn, bramble. Some large gaps. Negligible suitability for roosting bats. Moderate suitability for commuting and foraging bats.	N: 434807.859638 E: 503052.467984

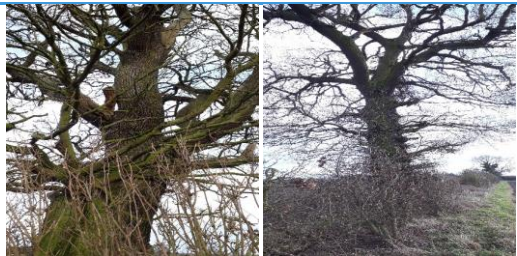
Target Note (TN) Reference	Description	British National Grid	Photograph Thumbnail
TN354	Two oaks with limited visible PRFs. Low suitability for roosting bats.	N: 434794.389561 E: 502458.166903

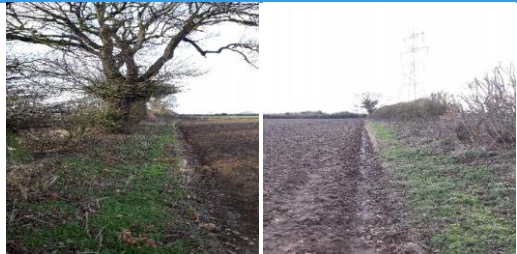
TN358	Arable field (JNCC: J1.1) – ploughed field.	N: 434749.895122 E: 503768.62608	n/a.
TN359	Arable field (JNCC: J1.1) – ploughed field.	N: 434737.569993 E: 503559.374399	n/a.
TN360	Species poor hedge with trees (JNCC: J2.3.2) consisting of hawthorn, oak and bramble with some small gaps. Moderate suitability for commuting and foraging bats.	N: 434729.434167 E: 502468.773216
