Hornsea Project Four: Preliminary Environmental Information Report (PEIR)

Volume 6, Annex 3.4: Great Crested Newt Environmental DNA (eDNA) Survey Report

A6.3.4
Version A

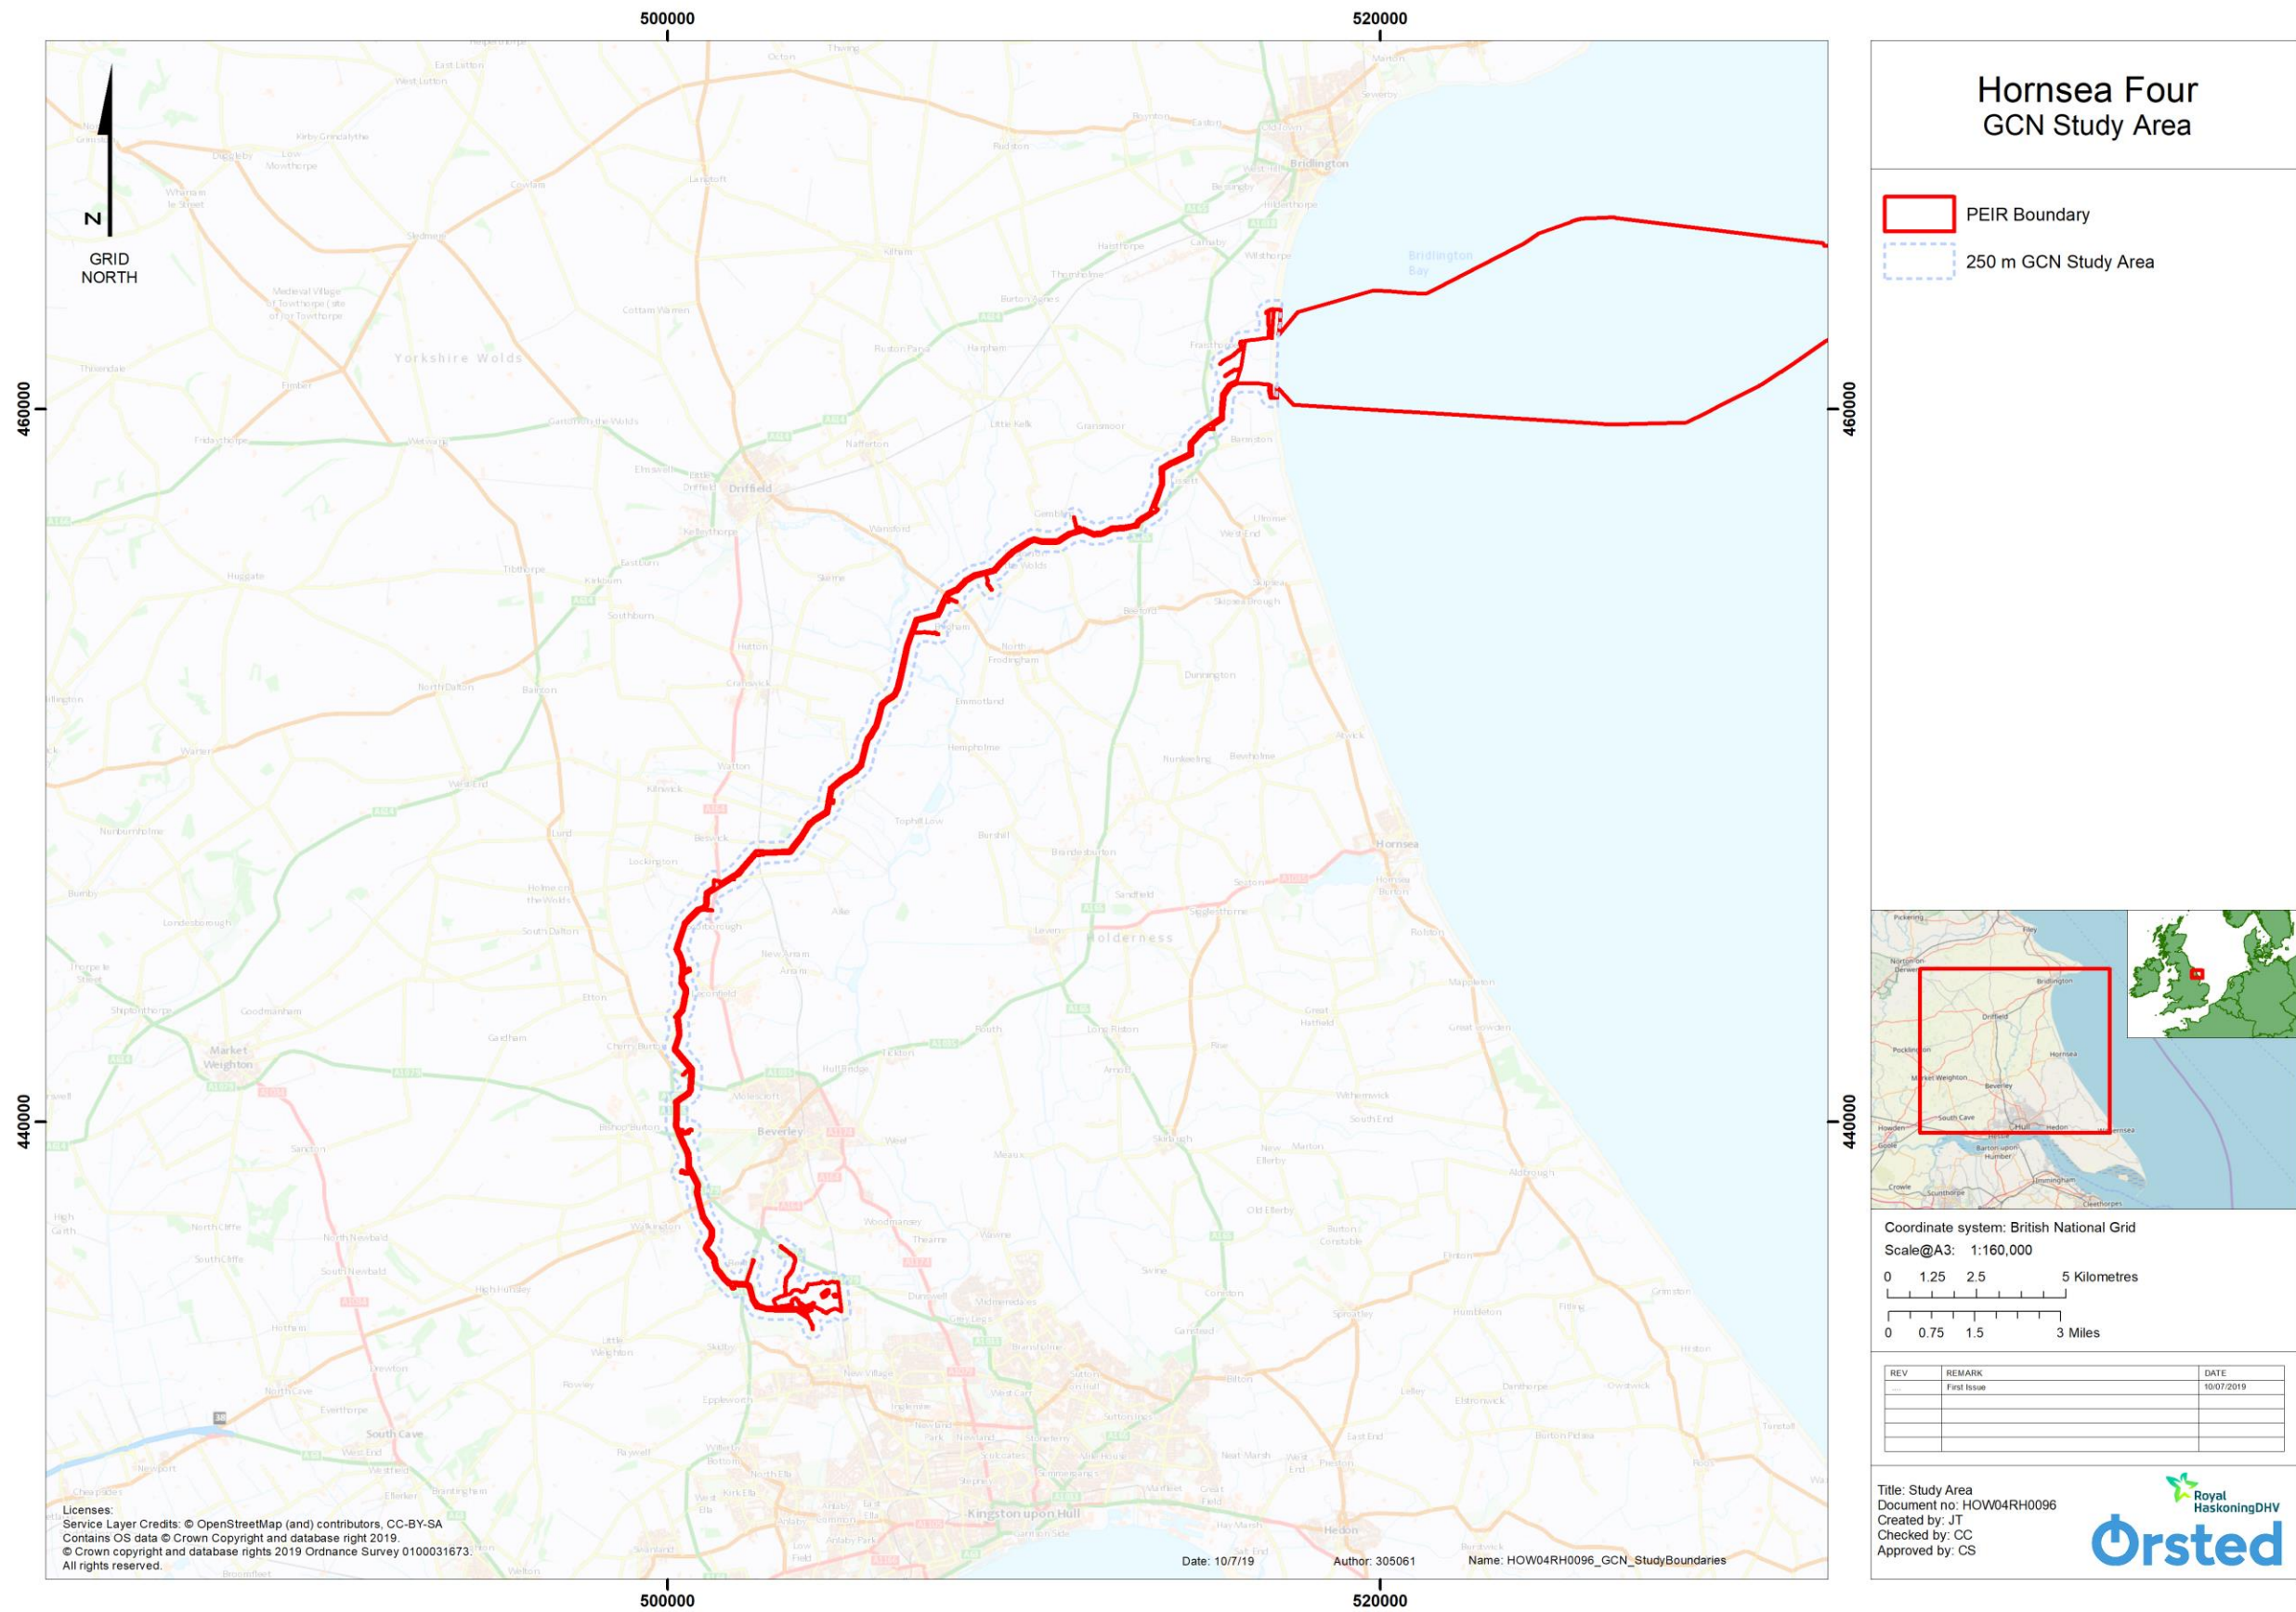
Figure 1: GCN Survey Area (Not to Scale).

3.2.1.2 Ordnance Survey (OS) mapping was then used identify all ponds within the Hornsea Four GCN survey study area. A total of 84 potential ponds were identified as shown on [Figure 2 - Figure 26](#). During the GCN eDNA survey undertaken in June 2019, an additional pond was recorded by surveyors, therefore giving a total of 85 ponds. These 85 ponds form the basis of the 2019 GCN eDNA survey.

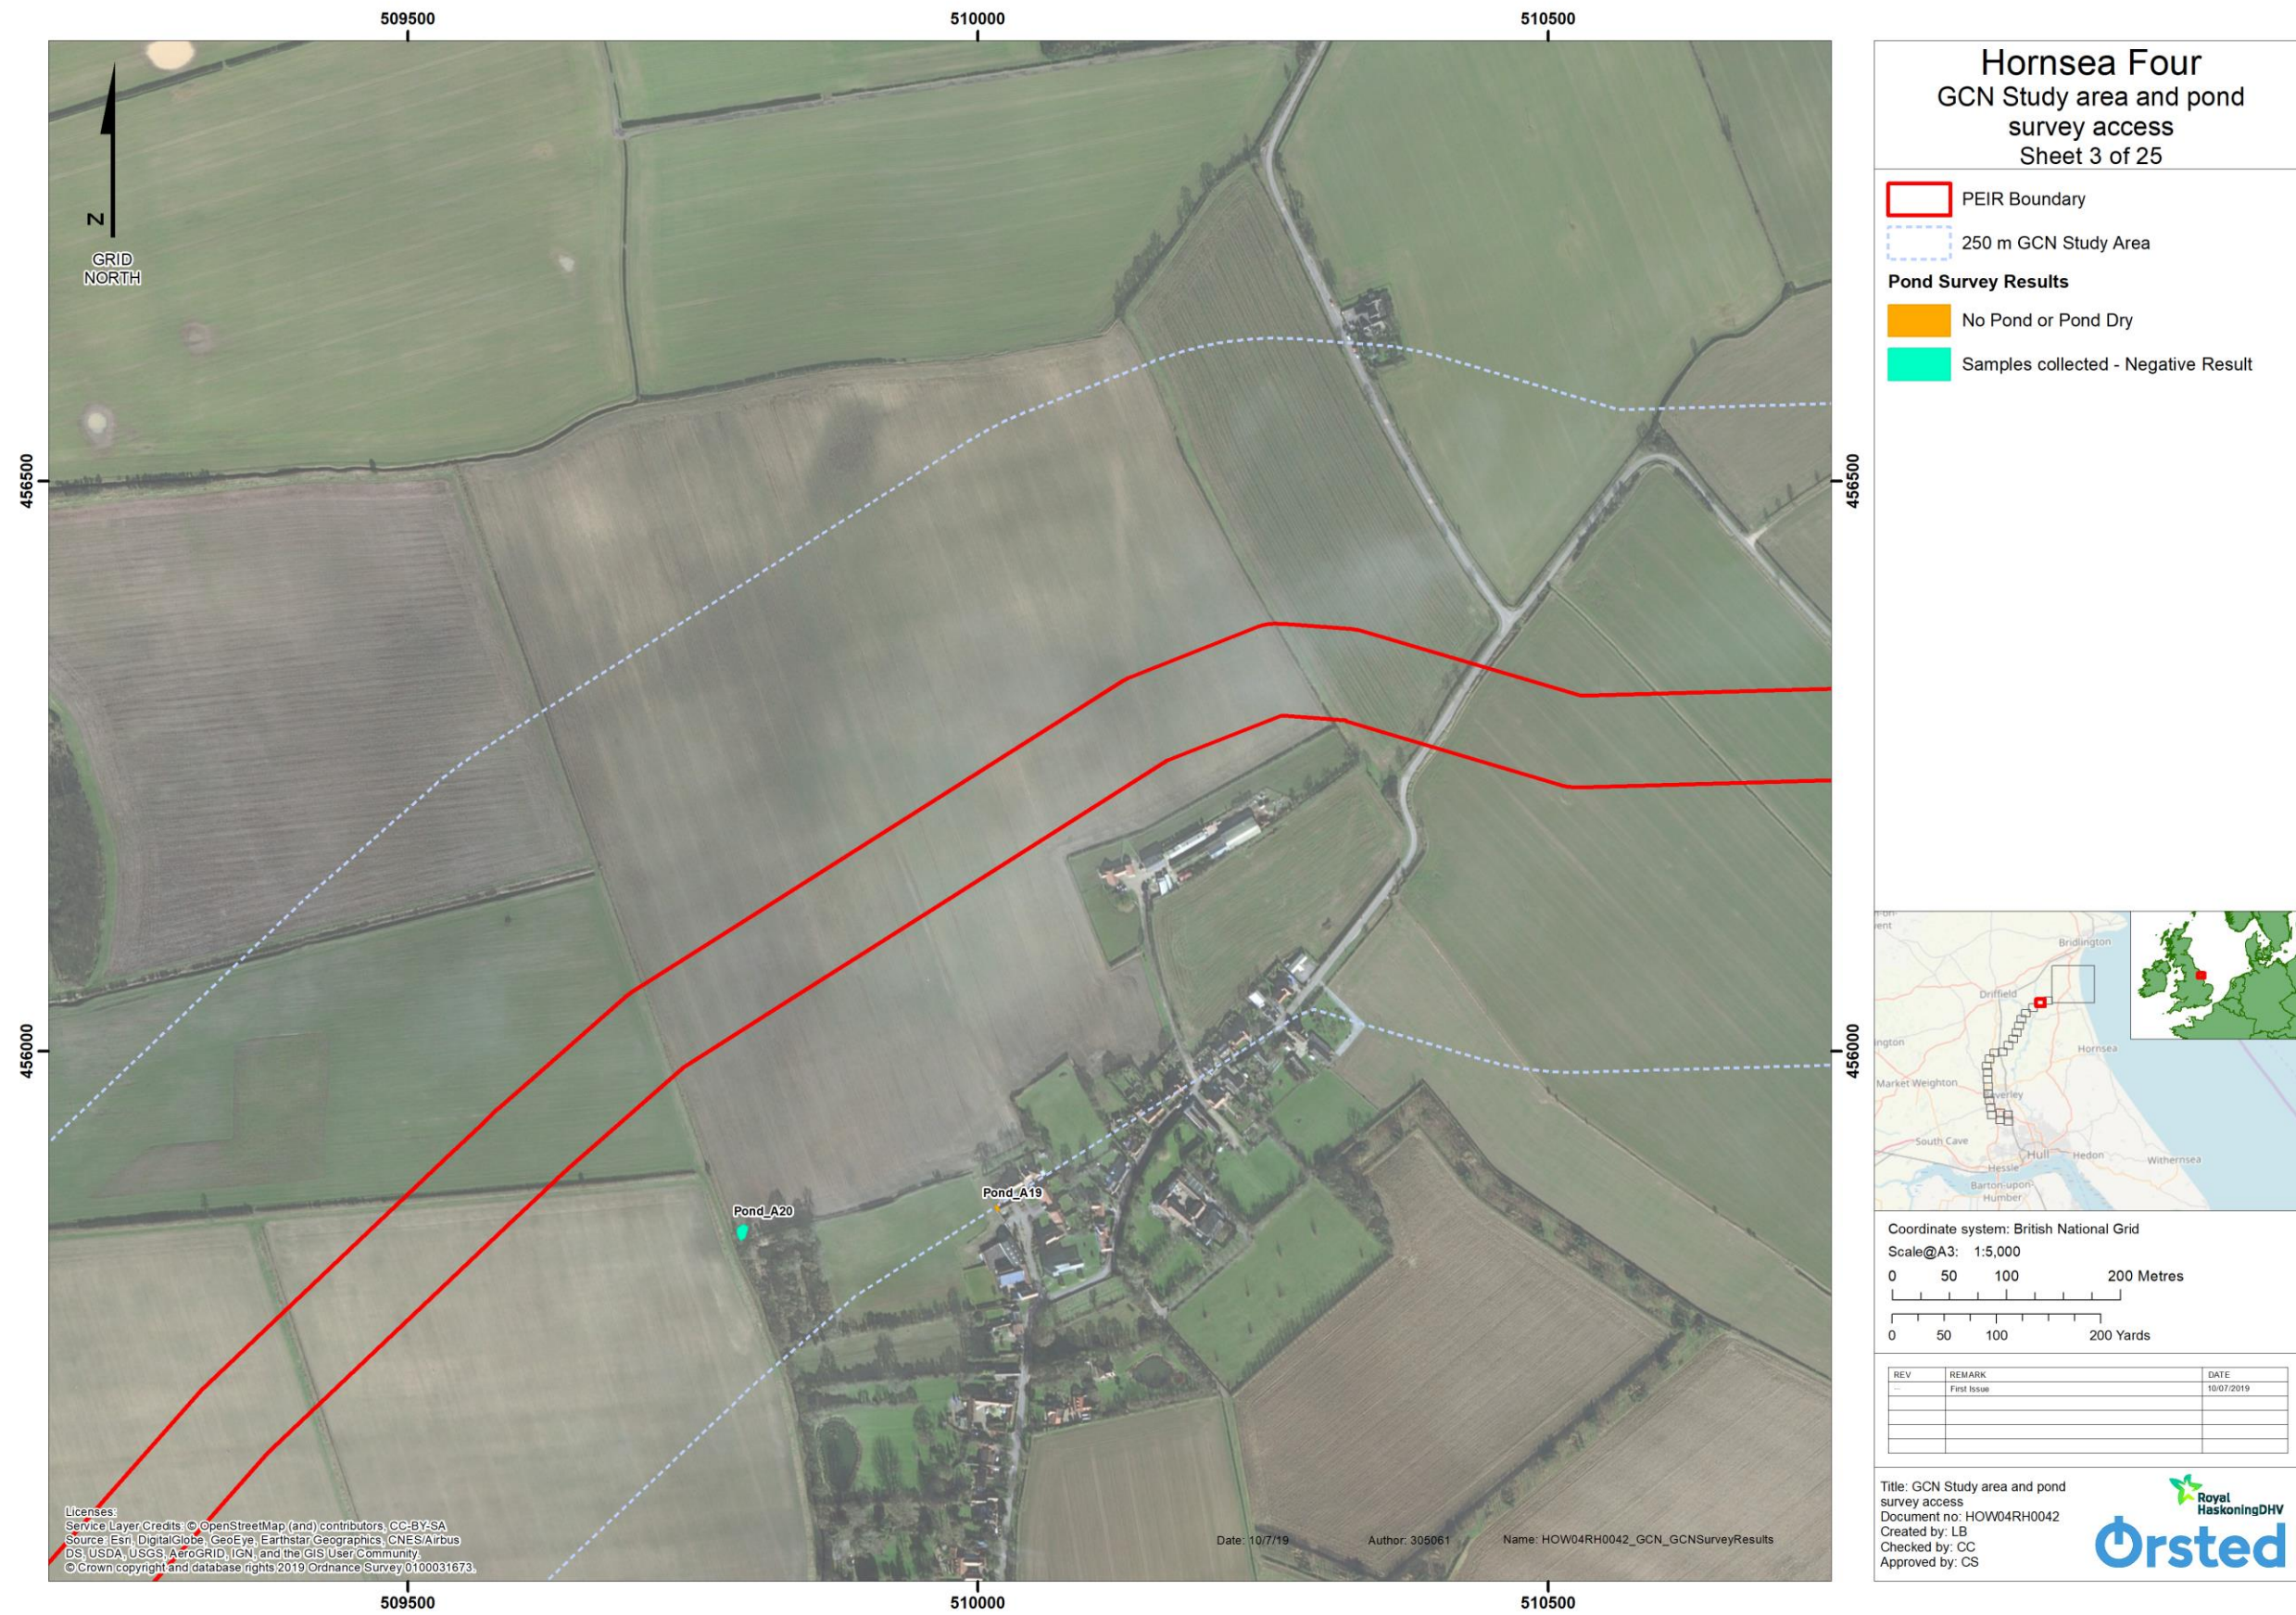
Figure 3: GCN Survey Results (Not to Scale).

- 5.1.1.4 Pond_A08 and Pond_A11 ([Figure 3](#)) are situated within approximately 130 m of each other, within an area of grassland that is maintained for the production of silage. The surrounding habitat consists of semi-improved grassland with standalone trees and patches of scrub, offering both hibernation and foraging opportunities for GCN.

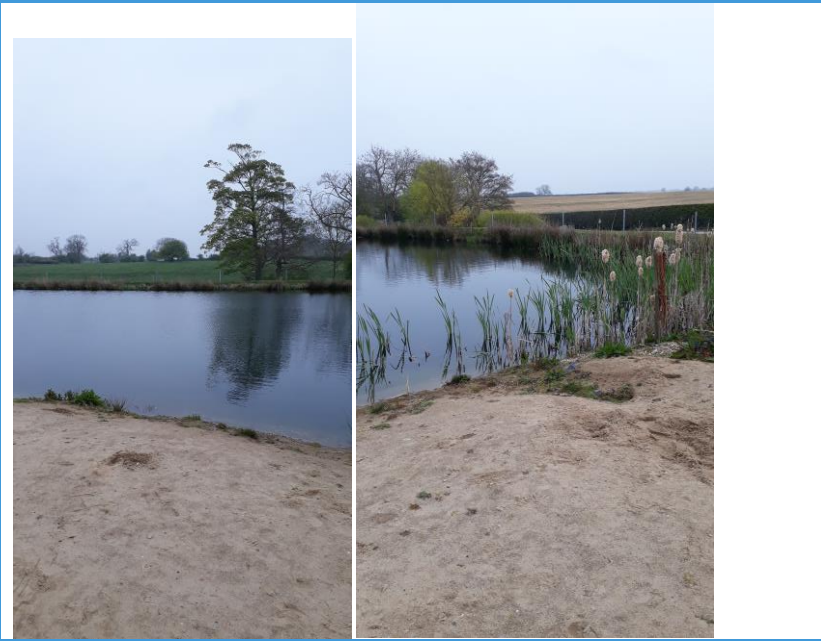
Pond Reference	Pond Description	Photograph
Pond_A07	Large pond within gardens. Bulrush, glyceria and soft rush present. Fenced and surrounded by maintained short sward grass.

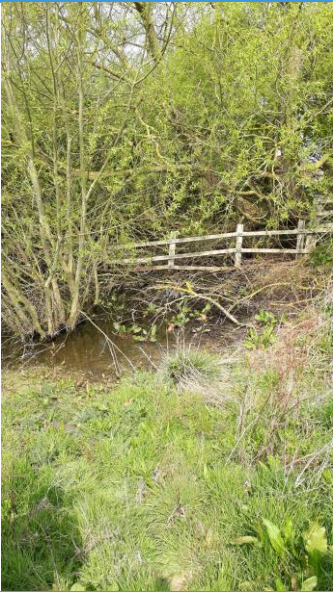
Pond Reference	Pond Description	Photograph
Pond_A08	Small pond with limited aquatic vegetation; willow, dock leaf, soft rush, fenced through middle of pond.

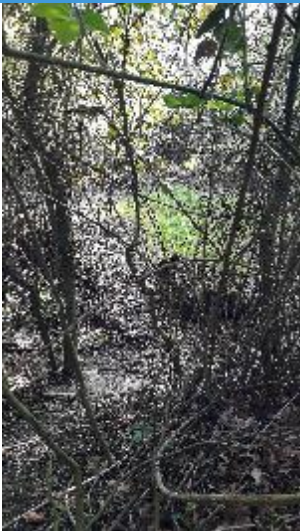
Pond Reference	Pond Description	Photograph
Pond_A10	Dry pond.

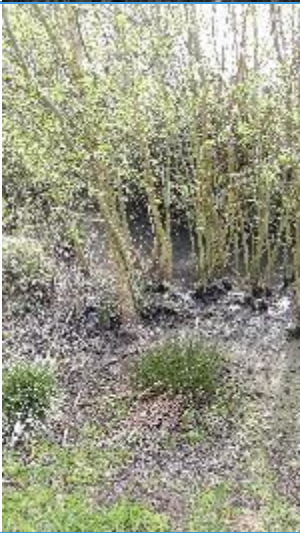
Pond_A11	Long narrow pond surrounded by vegetation including; hawthorn, willow, bramble, nettle, soft rush. Within grassland used for silage.

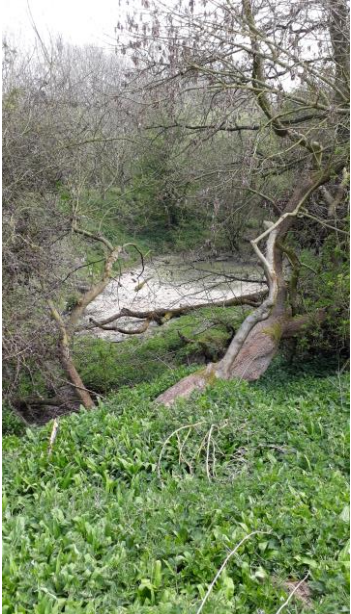
Pond Reference	Pond Description	Photograph
Pond_A12	Small crescent shaped pond, very shallow in small wooded copse. Fed by drainage ditches from arable fields.

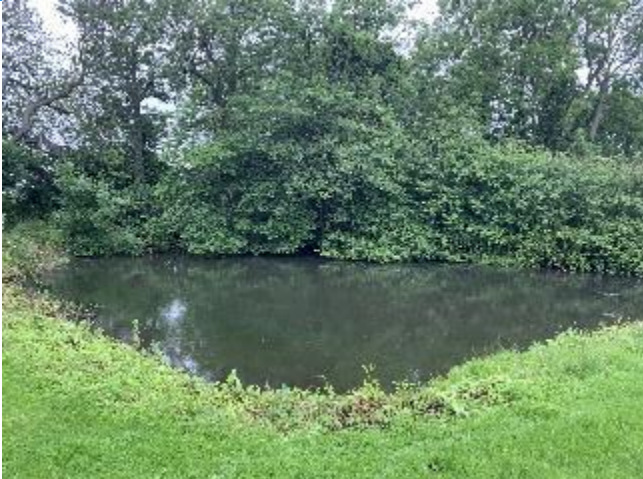
Pond_A13	Ornamental pond next to farmhouse. Set in amenity grassland with woodland to north east and arable fields.

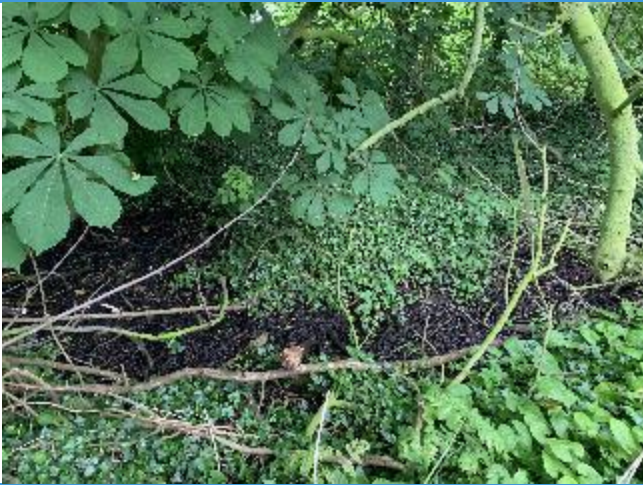
Pond Reference	Pond Description	Photograph
Pond_A14	Dry pond. Small ditch joins Pond_A13 and Pond_A14, completely dry and dense vegetation.

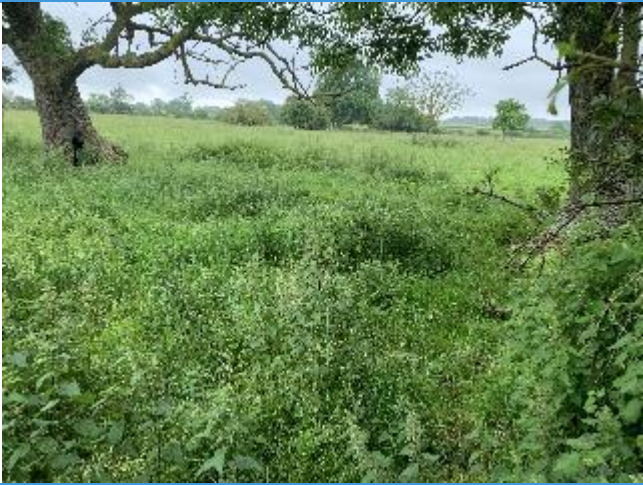
Pond_A15	No access to pond possible due to livestock present in field.	No photograph available as access was not possible due to presence of livestock at the time of the survey.
Pond_A16	Dry pond. Small vegetated scrape in the ground poached by cattle under ash trees, no water.

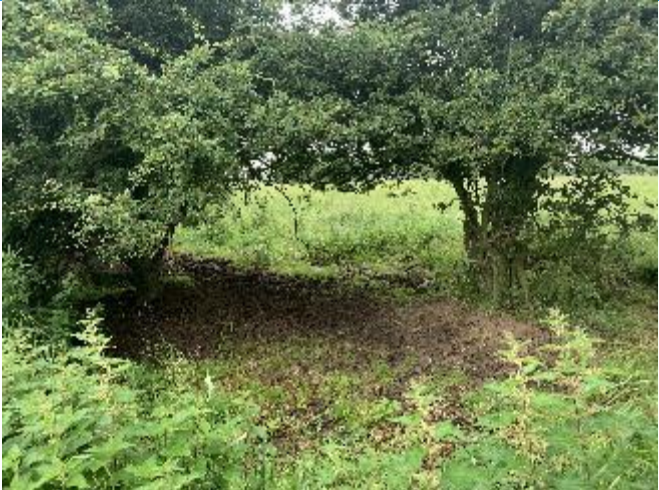
Pond Reference	Pond Description	Photograph
Pond_A17	Dry pond. Small vegetated scrape in the ground poached by cattle under ash trees, no water.

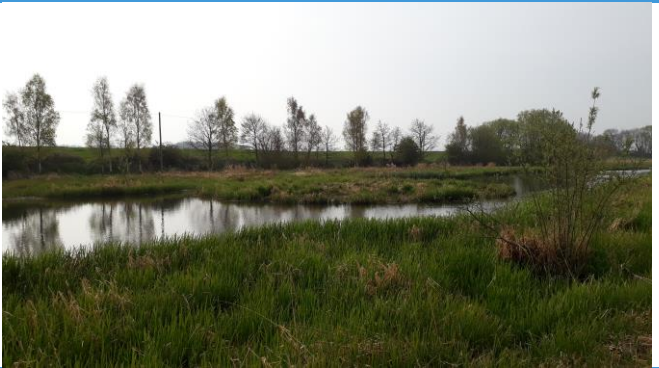
Pond_A18	Large pond within grassland, majority of bank covered in glyceria, island in middle of pond. Good connectivity to Pond_A06 and Pond_A07. Due to size of pond, two eDNA kits were used.

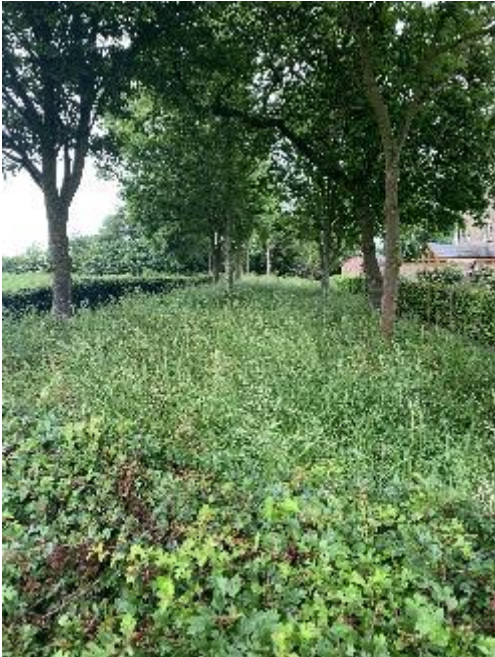
Pond Reference	Pond Description	Photograph
Pond_A19	No pond present.

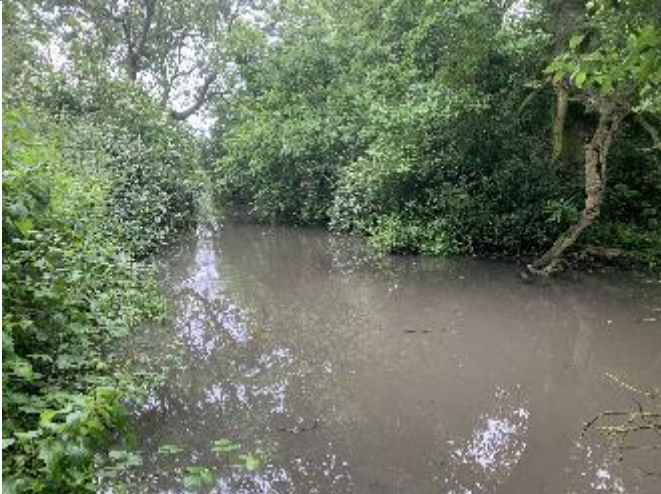
A photograph showing a field of tall, dense green grass and weeds. In the background, there are several trees with green foliage and a glimpse of a building.
Pond_A20	Large pond in small woodland. Highly overgrown and therefore difficult to access. Very little marginal vegetation.

A photograph of a narrow, shallow pond or stream flowing through a dense woodland. The water is dark and reflects the surrounding trees. The banks are heavily overgrown with green vegetation, making the pond difficult to access.

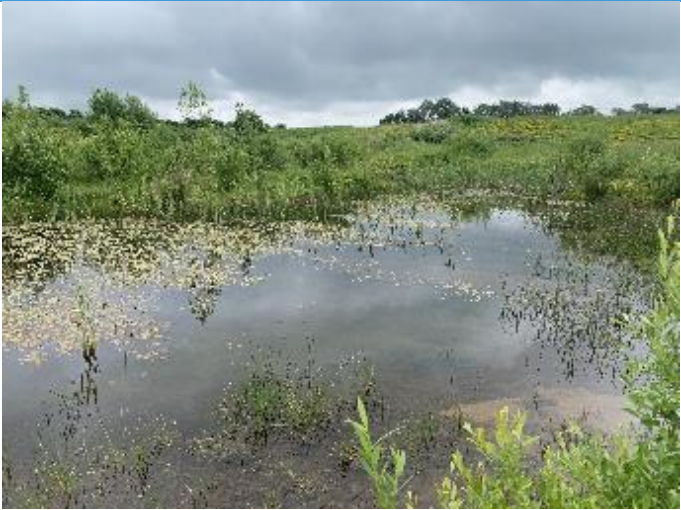
Pond Reference	Pond Description	Photograph
Pond_A23	L shaped pond remnant from sand/gravel extraction (as Pond_A22). Surrounded by semi-improved grassland comprising cock's foot, birds foot trefoil and teasel. Good connectivity to other ponds.

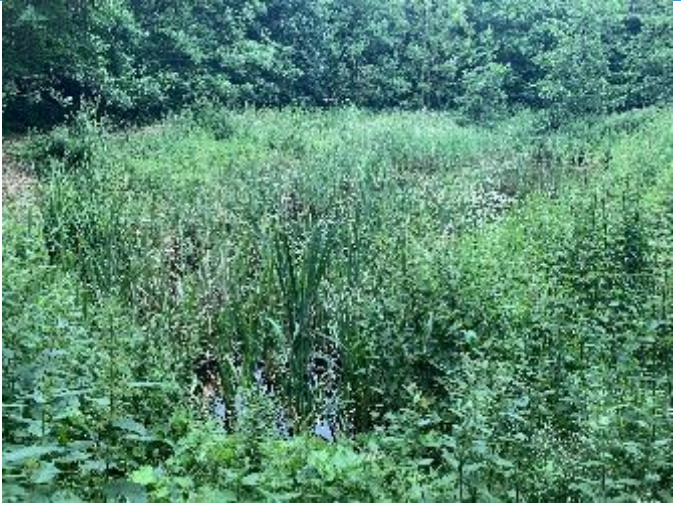
Pond_A24	Pond in centre of woodland. Pondweed, iris and bulrush. Water quality good, excellent connectivity to surrounding terrestrial habitats.

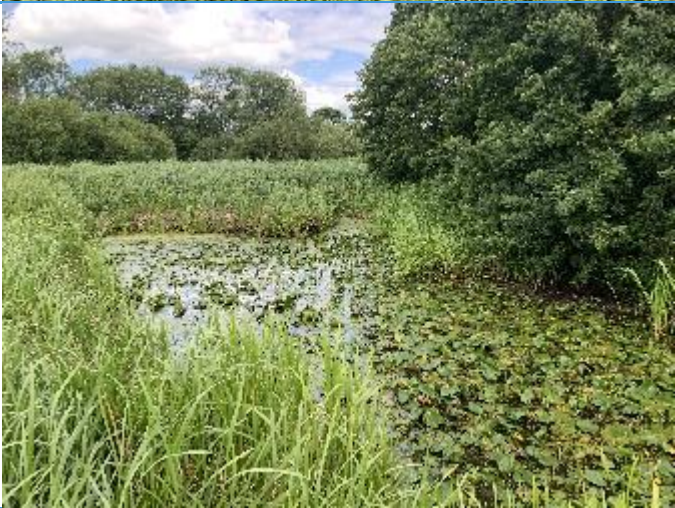
Pond_A29	Small remnant of Pond_A28 divided by mound of vegetated earth, choked with water lily, water quality okay, surrounded by chest high vegetation. Good connectivity

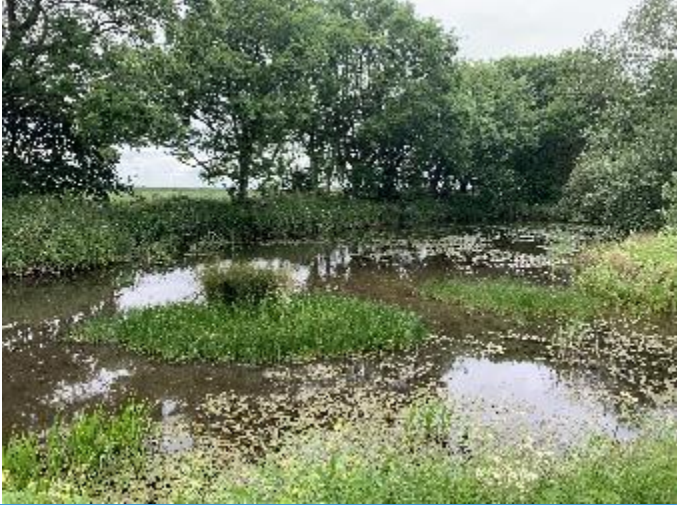
Pond_A33	Large pond once stocked with trout, little vegetation in bottom, spring fed with a gravel bottom.

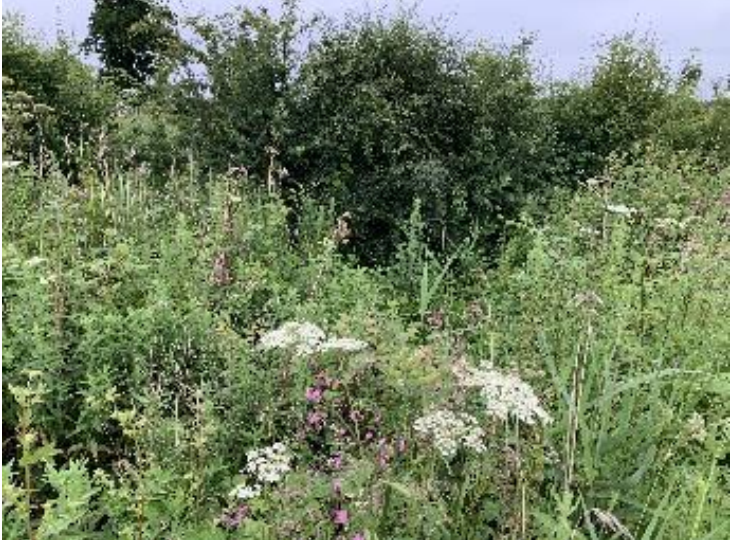
Pond Reference	Pond Description	Photograph
Pond_A37	No pond, small scrape in ground choked with vegetation. Looks like flood plain for the Bryan Mills Beck.

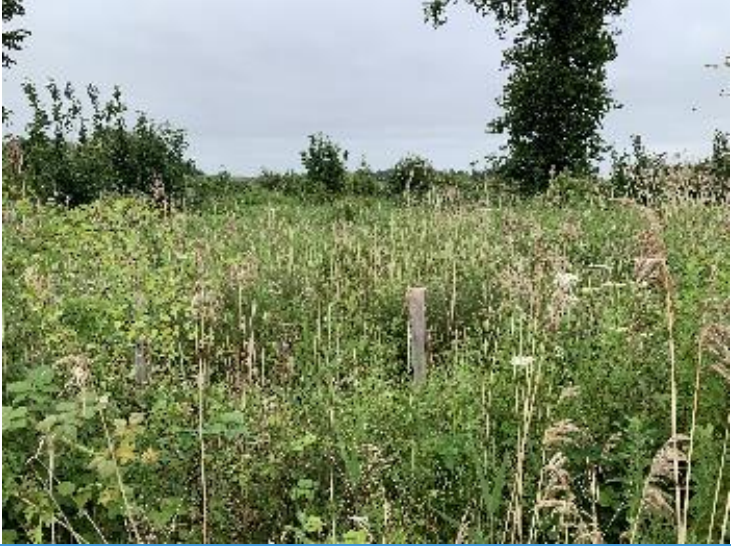
Pond_A38	No pond, small scrape in ground choked with vegetation. Looks like flood plain for the Bryan Mills Beck.

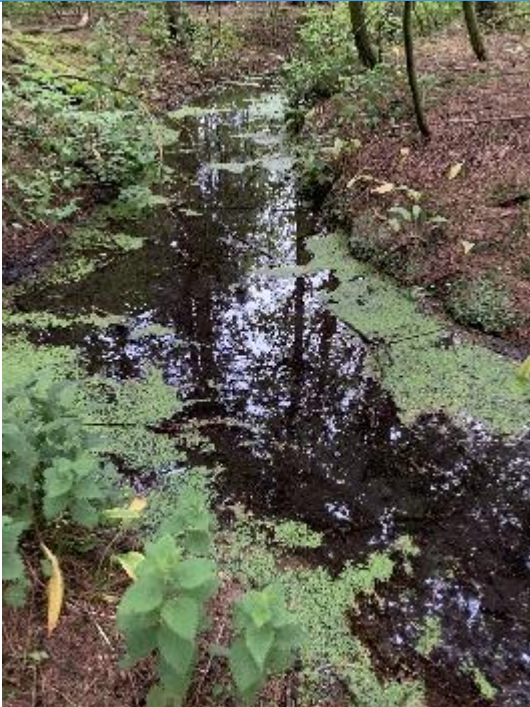
Pond Reference	Pond Description	Photograph
Pond_A43	Linear spring fed stream, slight slow flow towards Bealeys Beck in area of plantation woodland.

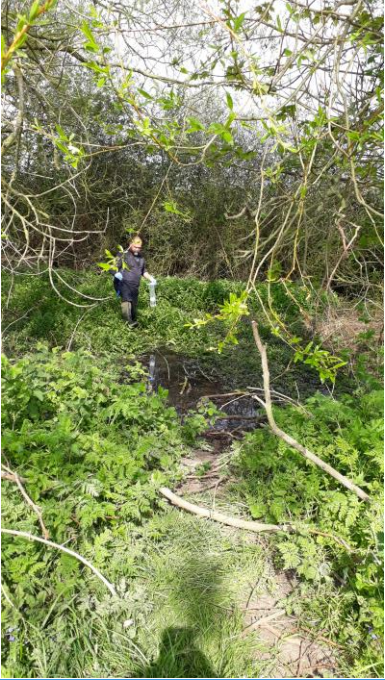
Pond Reference	Pond Description	Photograph
Pond_A44	Small, heavily shaded pond at edge of arable fields, adjacent to hedgerow and public right of way, feeds into ditch, partially dry.

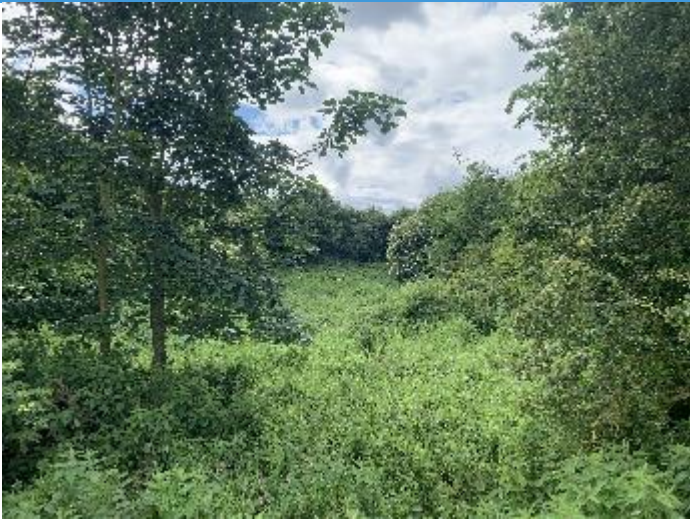
Pond Reference	Pond Description	Photograph
Pond_A45	Dry pond.

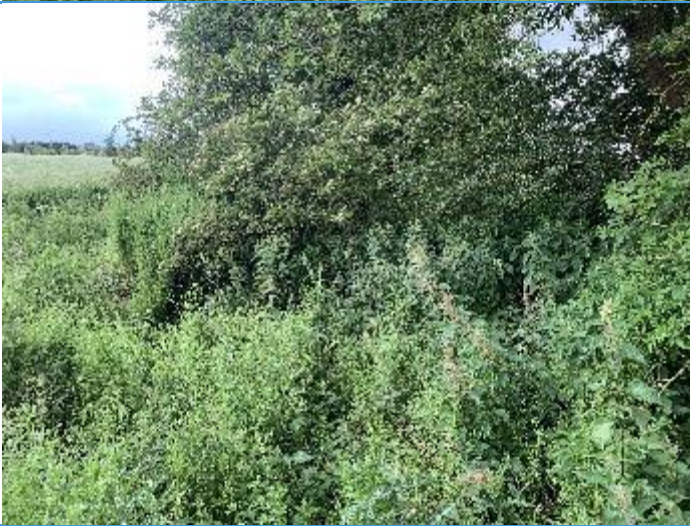
Pond_A46	No pond present.

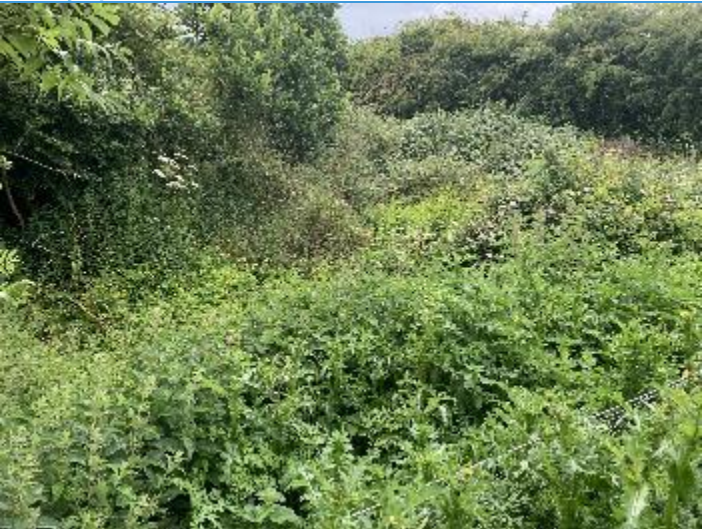
Pond Reference	Pond Description	Photograph
Pond_47	Small pond/hollow in side of arable field completely covered in vegetation/buttercup and dog rose. Water 2" to 3" deep.

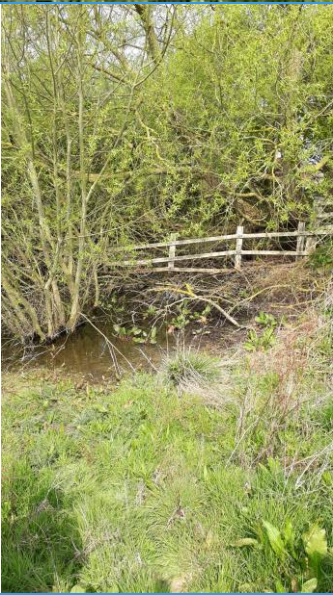
Pond_A48	<p>This is not a pond but a wide section of ditch that is currently dry. However, a garden pond is present, and this is referenced Pond_A48 and therefore surveyed.</p> <p>Small pond, glyceria throughout, fish pond adjacent (not connected).</p>

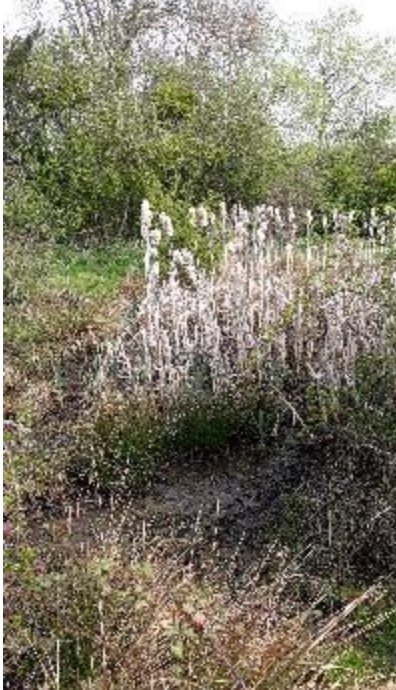
Pond Reference	Pond Description	Photograph
Pond_A49	Dry pond.

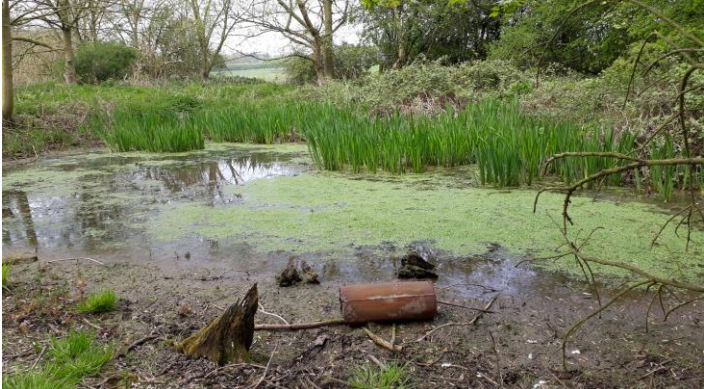
Pond_A50	Small pond within woodland (habitat rich, potentially ancient woodland); glyceria duckweed, sycamore, field maple, willow, ramsons, nettle, bramble, red-dead nettle, white-dead nettle, bluebells, red campion, forget me not, lesser celandine, ground ivy

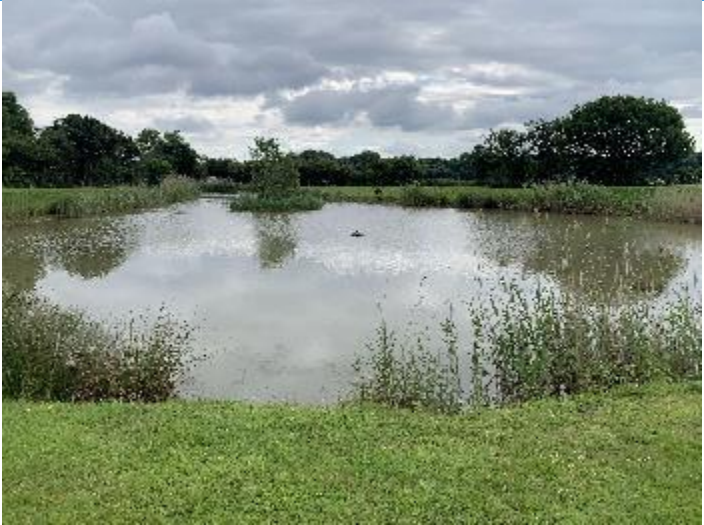
Pond Reference	Pond Description	Photograph
Pond_A51	Pear shaped ornamental pond (lined). Few iris and bulrush planted around edge. Bitumen lined with large fish ad moorhen present. Mowed lawns surround.

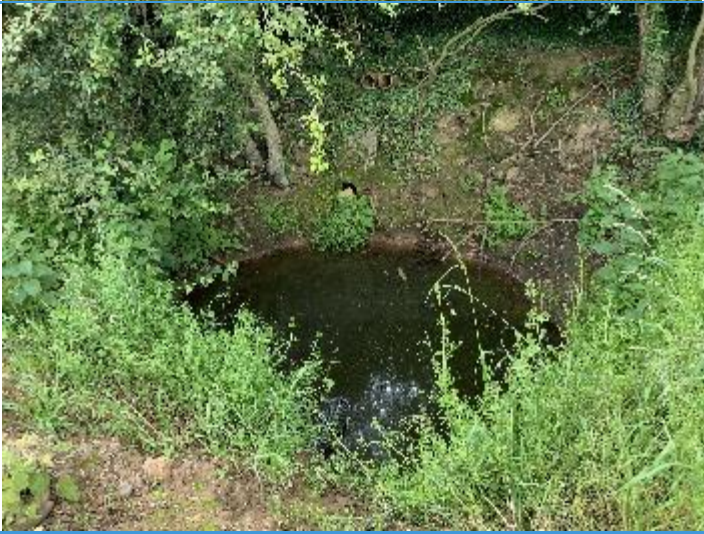
Pond_A52	Small round pond fed by pipe under the road/runoff. Steep bank with no vegetation.

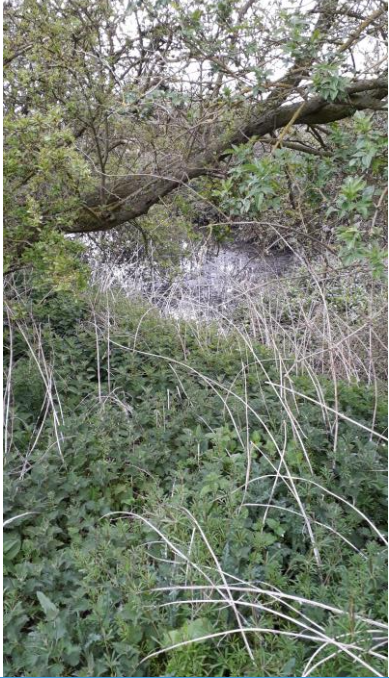
Pond Reference	Pond Description	Photograph
Pond_A53	Pond is a wide section of a (dry) ditch, between an arable field (ploughed) and grassland, fenced. Sycamore, nettle, bramble, dock, cleavers, white dead nettle and hawthorn. Grassland potentially used as grazing for farm

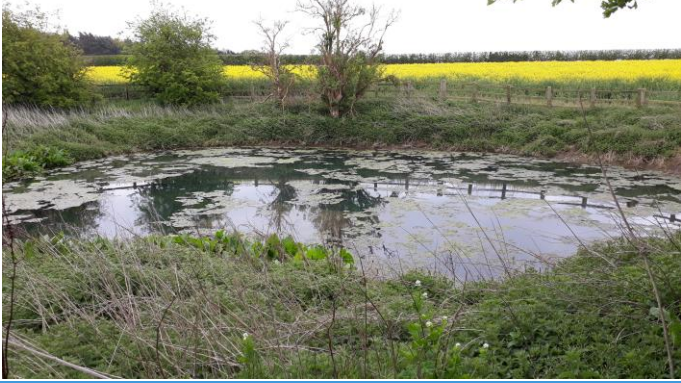
Pond_A54	Medium sized pond in middle of arable field (in crop - oilseed), fenced and gated (gate sign stated 'pollution control'). Manhole cover visible at bottom of pond. Surrounded by grass, broad leaf dock and hawthorn, some pond scum on surface, could potential be SUDS for A164. Disconnected from wider habitat by arable crops and roads

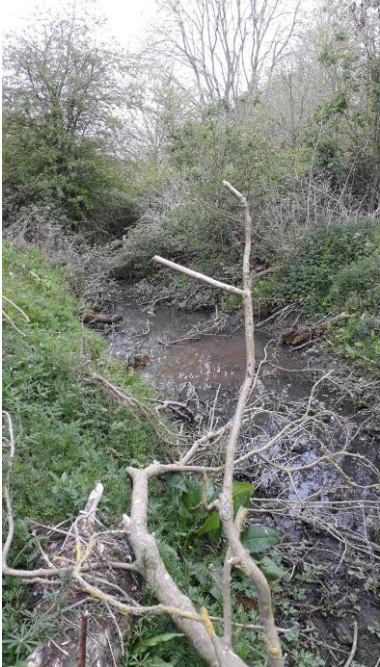
Pond Reference	Pond Description	Photograph
Pond_A55	Small pond in woodland adjacent to grassland. Sycamore, bramble, ribwort plantain, nettle, cow parsley, cleavers, dog mercury. Shallow pond approximately 15cm deep

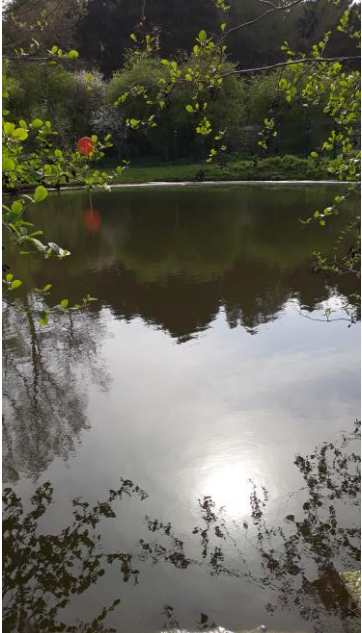
Pond Reference	Pond Description	Photograph
Pond_A58	Medium sized fish pond within animal paddock surrounded by alder, bramble and nettle

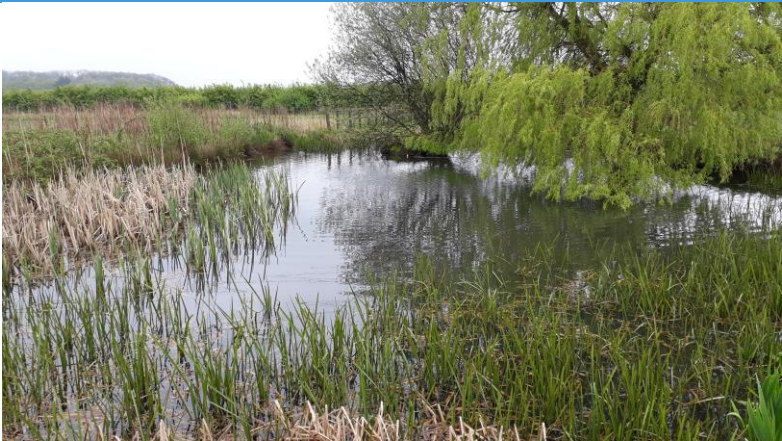
Pond Reference	Pond Description	Photograph
Pond_A60	Medium pond within garden and fenced horse paddock. Willow, hawthorn, broad leaf dock, glyceria, bulrush, soft rush. Common frogs present

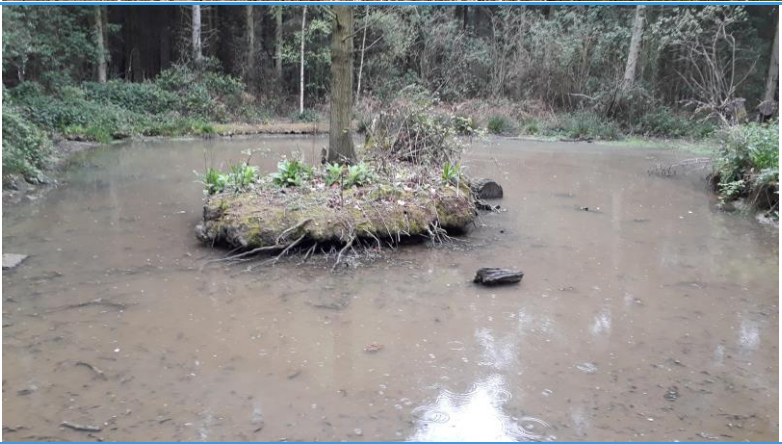
Pond_A61	Small pond in woodland adjacent to grassland. Sycamore, bramble, ribwort plantain, nettle, cow parsley, cleavers, dog mercury. Shallow pond approximately 15cm deep

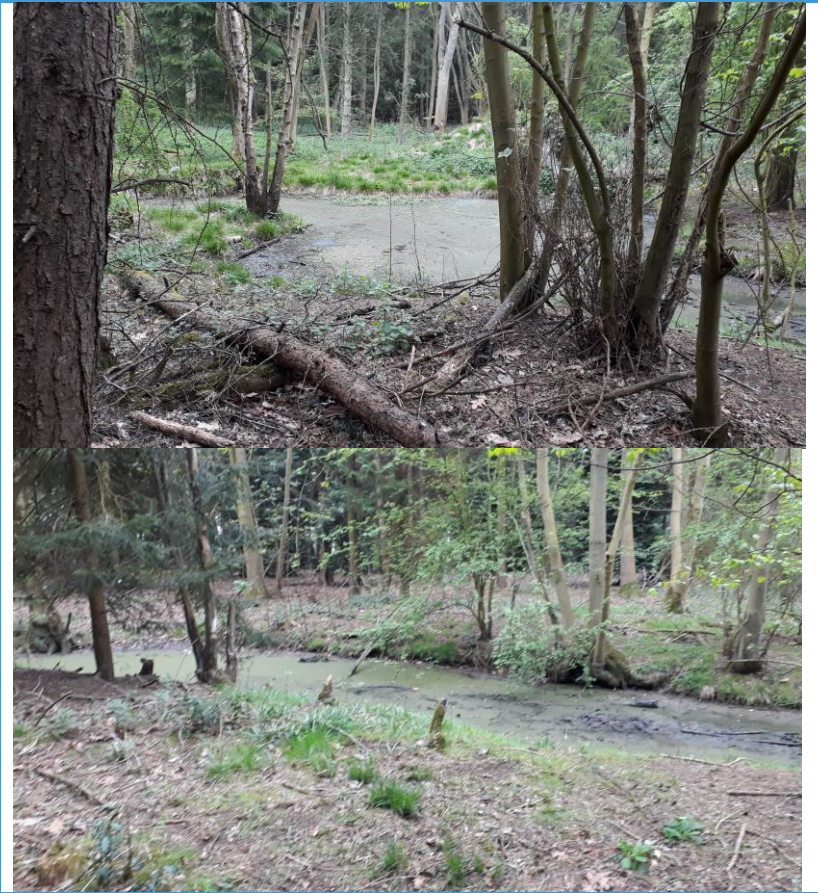
Pond Reference	Pond Description	Photograph
Pond_A62	Small pond in woodland, some aquatic vegetation at margins

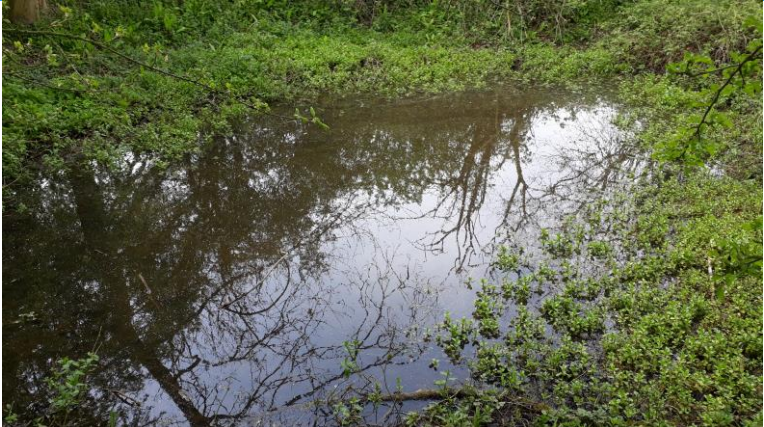
Pond Reference	Pond Description	Photograph
Pond_A63	Small ephemeral pond between arable fields and PRow. Water mint present, broad leaf dock, nettle, bramble, hawthorn and sycamore

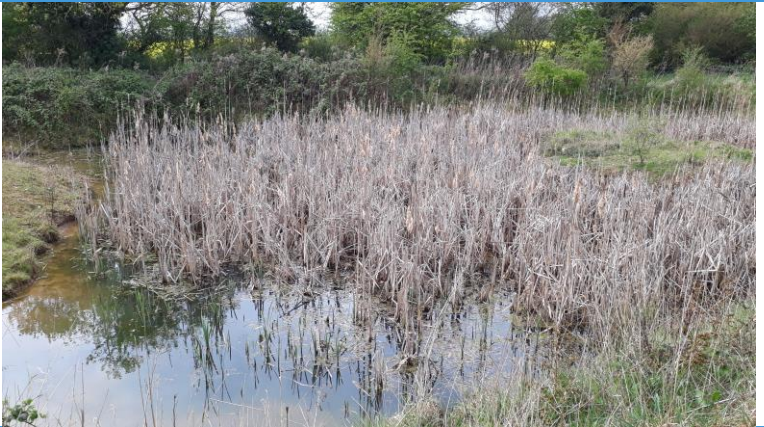
Pond_A64	Medium pond at corner of arable field adjacent to PRow, hedgerows, grassy field margins. Bulrush dominant throughout, bramble, nettle and hawthorn

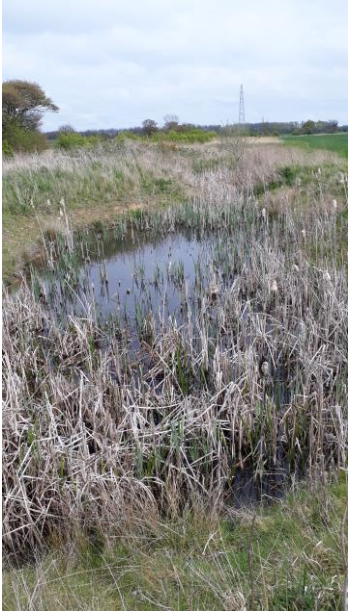
Pond Reference	Pond Description	Photograph
Pond_A65	Small pond at edge of arable field with wide field margins and hedgerow, tadpoles present. Bulrush, glyceria, hawthorn, soft rush and dandelion

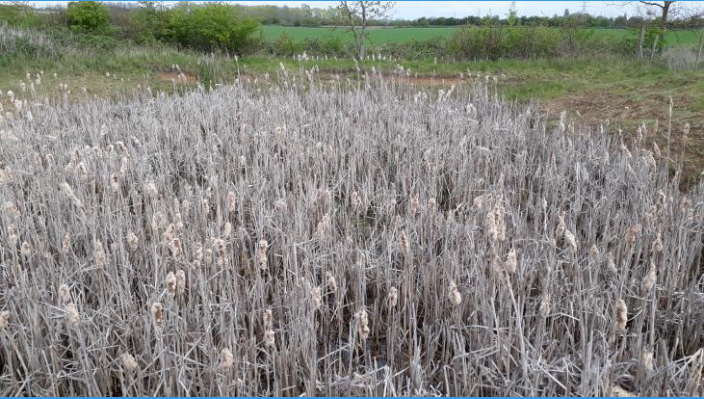
Pond_A66	Small pond at edge of arable field with wide grassy margins and scrub vegetation. Bulrush and glyceria throughout.

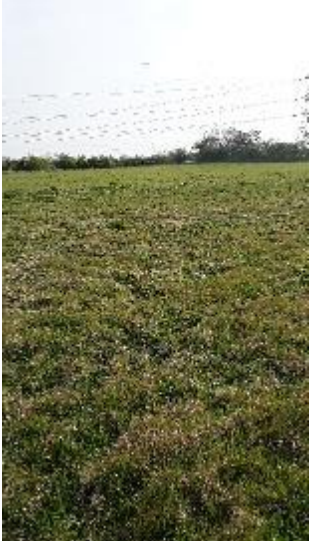
Pond Reference	Pond Description	Photograph
Pond_A69	No pond present.

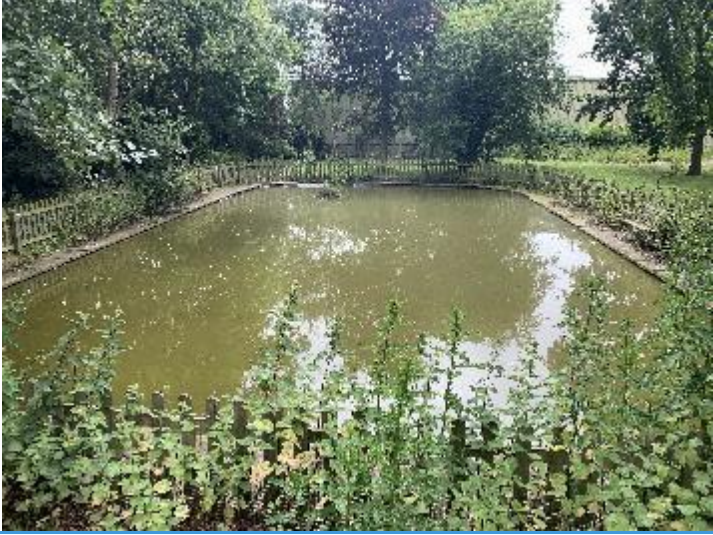
Pond_A70	Large concrete pond with bitumen liner. Surrounded by overhanging paving slabs set in amenity grassland and concrete.

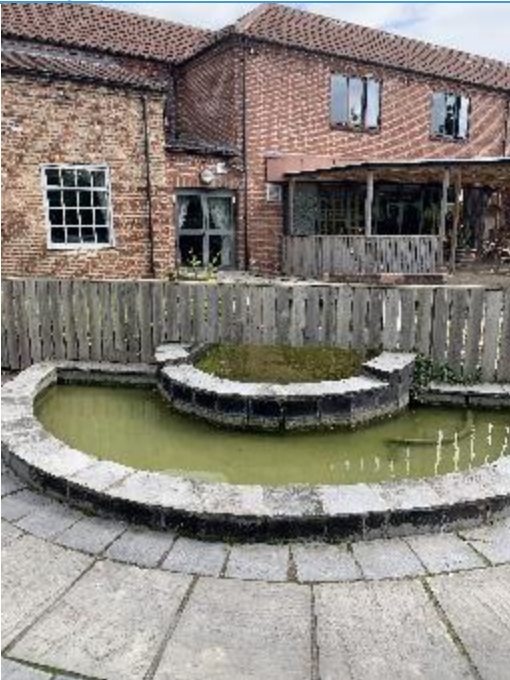
Pond Reference	Pond Description	Photograph
Pond_A82	Concrete ornamental pond with no vegetation. Pump visible and no fish.
