Hornsea Project Four: Preliminary Environmental Information Report (PEIR)

Volume 6, Annex 2.1: Geomorphological Baseline Survey Technical Report

A.6.2.1
Version A

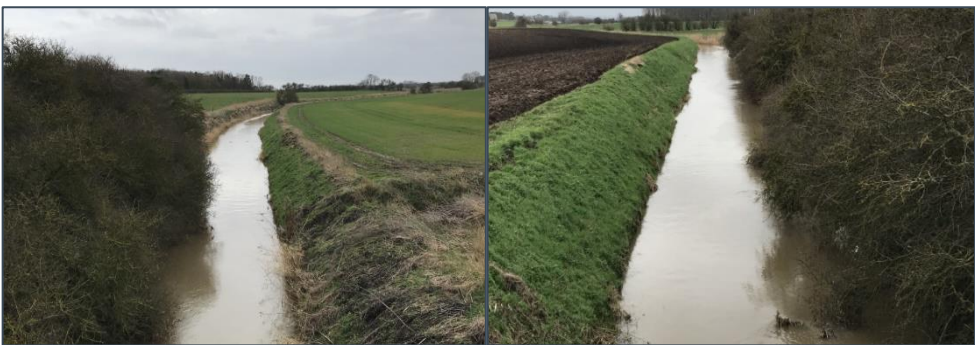
Parameter	Details
Overview	<p>Gransmoor Drain consists of a uniform incised channel that has been artificially straightened and incised adjacent to arable farmland (Plate 1).</p>

<p>Plate 1: Gransmoor Drain.</p>
Channel Form	<p>The channel has a straight planform. The banks are relatively steep, approximately 1 m – 2 m high, stable and well vegetated in places. Although large sections of bare banks are a feature throughout the study area. The channel is approximately 7 m – 10 m wide at the bank top; and 5 m wide at the bank base, displaying a typical U shape uniform channel (Plate 1). The substrate is dominated by sands and silts and appears to be a typical sediment deposition zone, with slow flows, low gradients and low velocities contributing to the settling out of fine sediments/silts.</p>

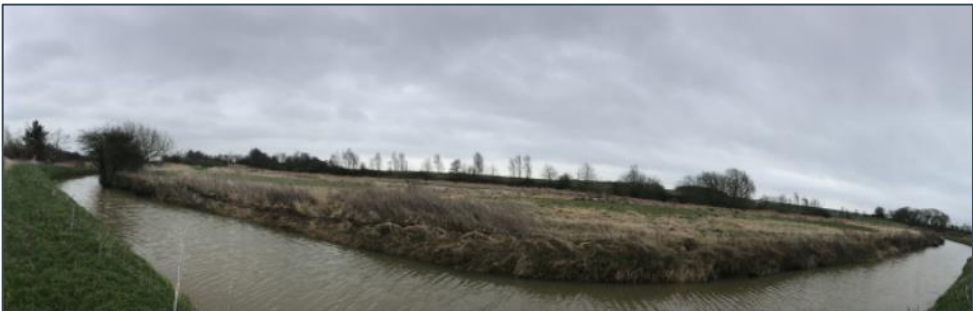
Parameter	Details
<p>Overview</p>	<p>The Barmston Sea Drain is approximately 15 km in length with a predominately straight planform. The channel displays very limited flow and geomorphological diversity, although large wetland features are evident on the floodplain directly north of the drain (Plate 2). However, overall the Barmston Sea Drain within the study area is typical of a large modified drainage system, with a uniform channel shape and incised as a result of historical re-sectioning and enlargement for land drainage purposes (Plate 2).</p>

<p>Plate 2: Barmston Sea Drain.</p>
<p>Channel Form</p>	<p>The channel has a straight planform. The banks are relatively steep, approximately 1 m – 2 m high, stable and well vegetated in places throughout the study area. The channel is approximately 7 m – 10 m wide at the bank top; and 7 m wide at the bank base, displaying a typical U-shape style channel (Plate 2). The substrate is dominated by sands and silts and appears to be a typical sediment deposition zone with slow flows, low gradients and low velocities contributing to the settling out of fine sediments/silts.</p>

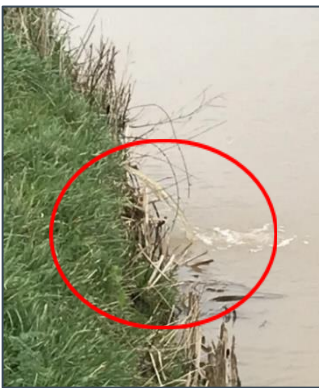
<p>Substrate Conditions</p>	<p>As stated above, the substrate is dominated by silts. Some local erosion of banks was evident alongside field drainage pipes and overland flow, all of which appear to contribute to local siltation of the channel bed within the study area (Plate 3). However, the dominant source of fine sediments appears to be associated with upstream land management practices.</p>

<p>Plate 3: Discharge from field drain into Barmston Sea Drain.</p>

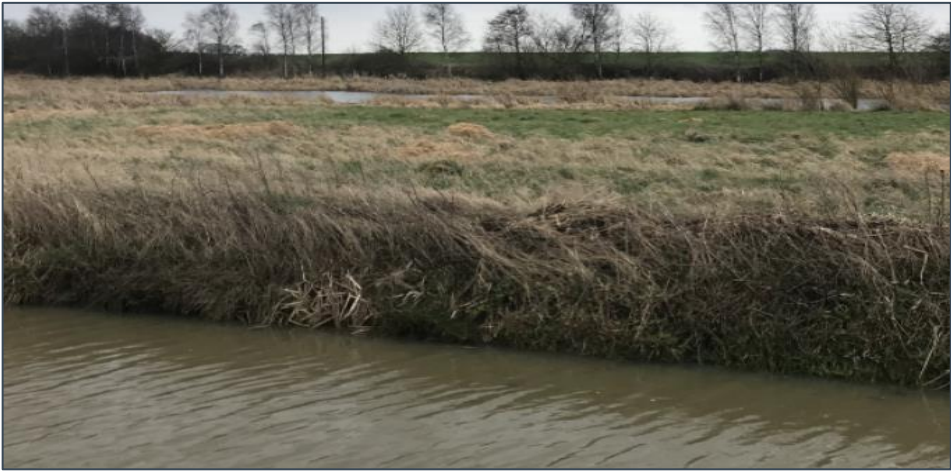
Parameter	Details
Flow (Habitat) Conditions	The wide, straight uniform channel is characterised by low energy glide flows, which were observed throughout the study area, with limited flow diversity or in-channel features.
Floodplain Characteristics	<p>Large floodplain wetland systems (Plate 2 and Plate 4) suggest that there is a good degree of floodplain connectivity in parts of the study area.</p>

<p>Plate 4: Wetland on the floodplain of the Barmston Sea Drain.</p>
In-channel / Riparian Vegetation	The banks and margins are well vegetated with rushes, sedges and reeds. There is some in-channel aquatic vegetation, although the vegetation is heavily silted (Plate 3).
Modifications / Structures	The channel is deeply incised and is likely to have been historically re-sectioned and enlarged for land drainage purposes.

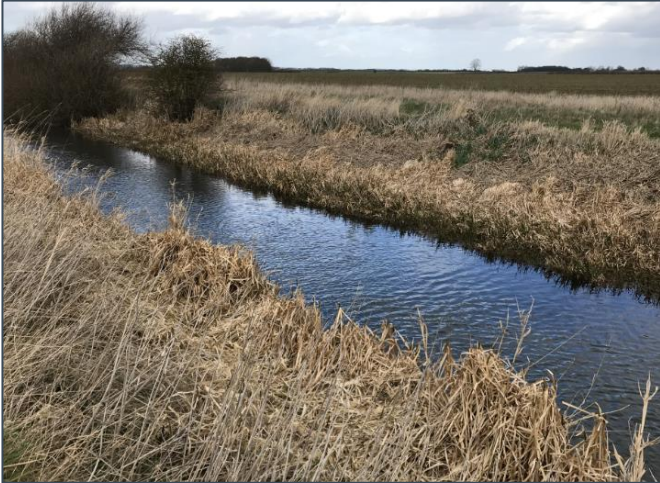
Parameter	Details
Overview	<p>The Foston Beck is chalk river approximately 13 km in length with a predominately straight planform. The channel displays limited flow and geomorphological diversity, although in places a two-stage channel is a feature (Plate 5). However, overall Foston Beck within the study area is typical of a large modified drainage system, with a uniform channel shape and bounded by embankments (Plate 5).</p>

<p>Plate 5: Foston Beck.</p>
Channel Form	<p>The channel has a straight planform. The banks are relatively steep, approximately 1 m high, stable and well vegetated in places throughout the study area. The channel is approximately 7 m – 10 m wide at the bank top; and 7 m wide at the bank base, displaying a two-stage channel in places, with a low flow channel and aligned with flood embankments (Plate 5). The substrate is dominated by sands and silts, resultant of a typical sediment deposition zone, with slow flows, low gradients and low velocities contributing to the settling out of fine sediments / silts. Limited exposures of the natural course substrates that would typically be expected in a chalk river were observed in this reach.</p>

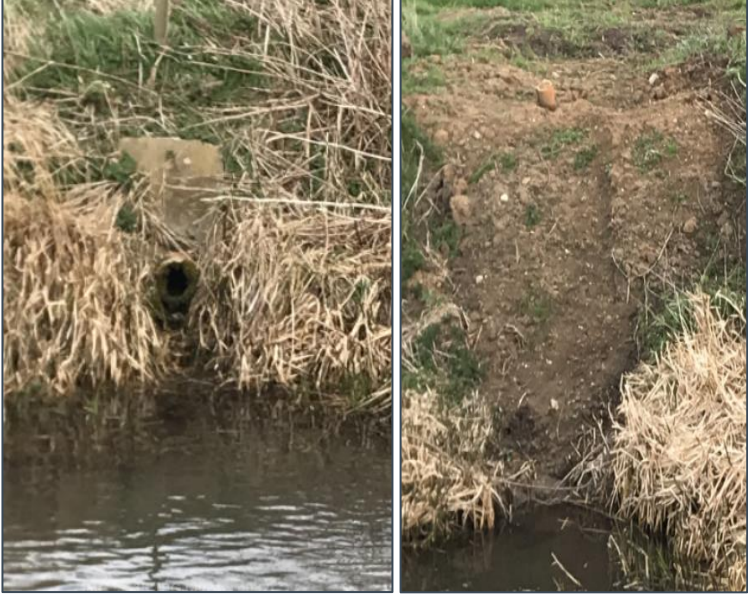
Substrate Conditions	<p>Temporary and semi-permanent fine channel deposits are present within the study area, as well as coarse deposits. Fine sediment deposits are mainly in the form of toe accumulation interspersed between marginal vegetation, with berm establishment in places. However, the channel is dominated by a silty flat bed, which may be the reason for the lack of aquatic vegetation within the study area. There is extensive fluvial erosion (toe scour) in places, although there was no evidence of geotechnical bank failure present during the time of the survey. There was also evidence of field drain outfalls and eroded access banks adjacent to arable land (Plate 6).</p>

<p data-bbox="466 936 1011 969">Plate 6: Sources of sediment to Foston Beck.</p>
Flow Conditions	<p data-bbox="466 1014 1350 1081">The wide, straight channel is characterised by low energy glide flows, which were observed throughout the study area, with some flow diversity and in-channel features.</p>
Floodplain Characteristics	<p data-bbox="466 1120 1369 1187">Foston Beck does appear to be constrained within the flood embankments. As such, limited floodplain connectivity along the beck was observed throughout the study area.</p>
In-channel / Riparian Vegetation	<p data-bbox="466 1225 1377 1359">The banks and margins are well vegetated with rushes, sedges and reeds. In places emergent aquatic vegetation in the channel was noted, although obscured by silt deposition (Plate 7). The submerged vegetation cover varies from 5% to 40% throughout the study area.</p>

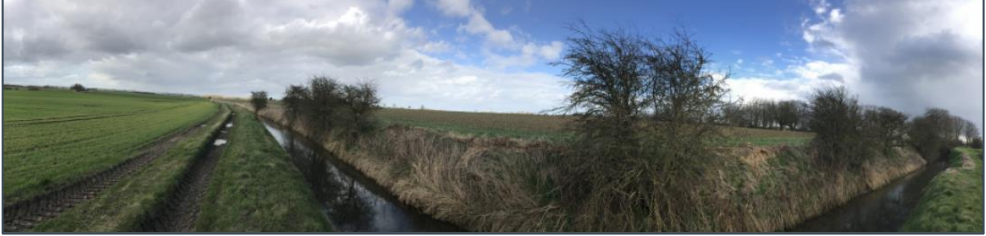
Parameter	Details
Overview	White Dike within the study area is a uniform, incised channel that has been artificially straightened and aligned with flood embankments adjacent to arable farm land (Plate 8). The channel is dominated by glide flows and silt deposition. No major sediment sources were noted, although drainage outfalls from the adjacent fields were noted, with possible local bank scour

<p>Plate 8: White Dike.</p>
Channel Form	<p>The channel has a straight planform and uniform morphology with a flat bed. The banks are relatively steep, approximately 1 m high, stable and well vegetated in places throughout the study area. The channel is approximately 7 m – 10 m wide at the bank top; and 6 m wide at the bank base. Both banks are aligned with flood embankments (Plate 8). The channel within the study area appears to be of a typical sediment deposition zone, with slow flows, low gradients and low velocities contributing to the settling out of fine sediments / silts along a flat bed with limited geomorphological complexity (Plate 9).</p>

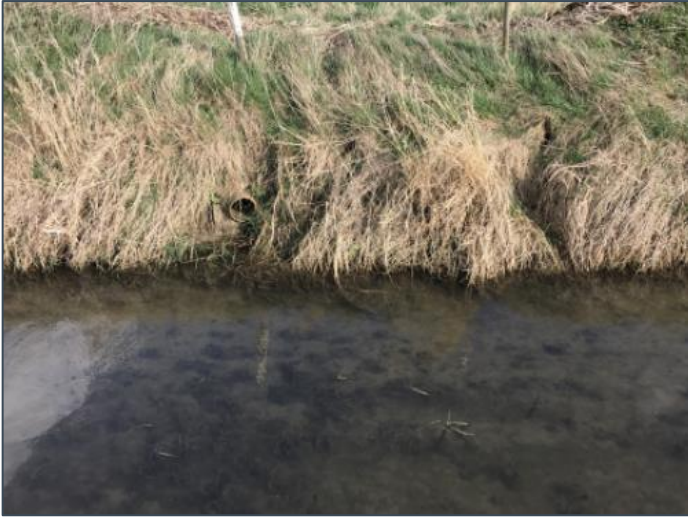
<p>Plate 9: Silt deposition and field drain outfall in White Dike.</p>
Substrate Conditions	<p>The substrate is dominated by sands and silts, although silts / fine sediments are the main substrate material overlying the sands. No major sediment sources were noted, although outfalls from the adjacent fields were noted, with possible local bank scour from bridge abutments. The dominant source of fine sediments appears to be associated with upstream land management.</p>

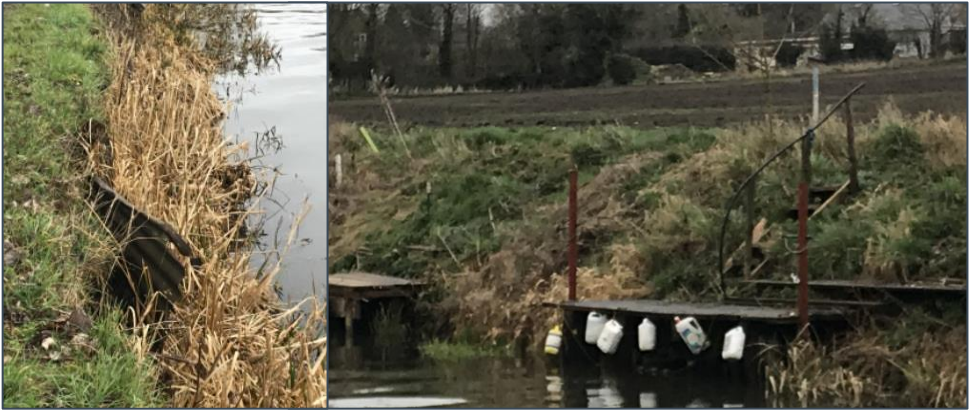
Parameter	Details
Modifications / Structures	<p>The Driffield Navigation is lined with a flood embankment along both channel banks, predominantly straight and with an enlarged channel. Local bank protection and boat moorings are present (Plate 14).</p>

<p>Plate 14: Structures on the banks of the Driffield Navigation (note the tilled land adjacent to the bank).</p>

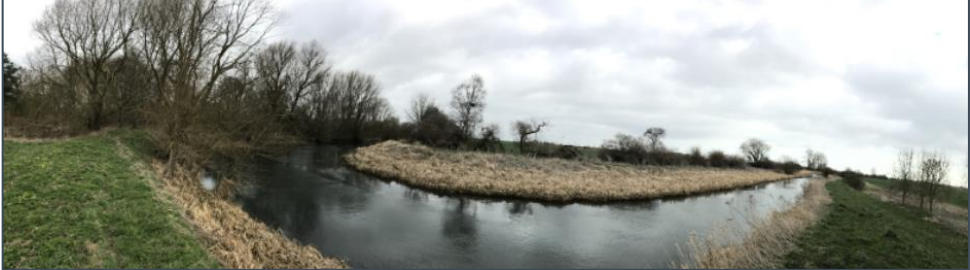
Parameter	Details
Overview	<p>West Beck within the study area is predominantly meandering, and has been historically over-deepened and over-widened for navigation purposes. As a result, the river is very deep, with steep banks and uniform flow conditions (Plate 15). The channel is largely bordered by flood embankments. Large parts of the banks are exposed, although there is localised tree and good wet woodland and backwaters (Plate 16). Cleaves Weir is located upstream of the study area.</p>

<p data-bbox="395 622 651 654">Plate 15: West Beck.</p>

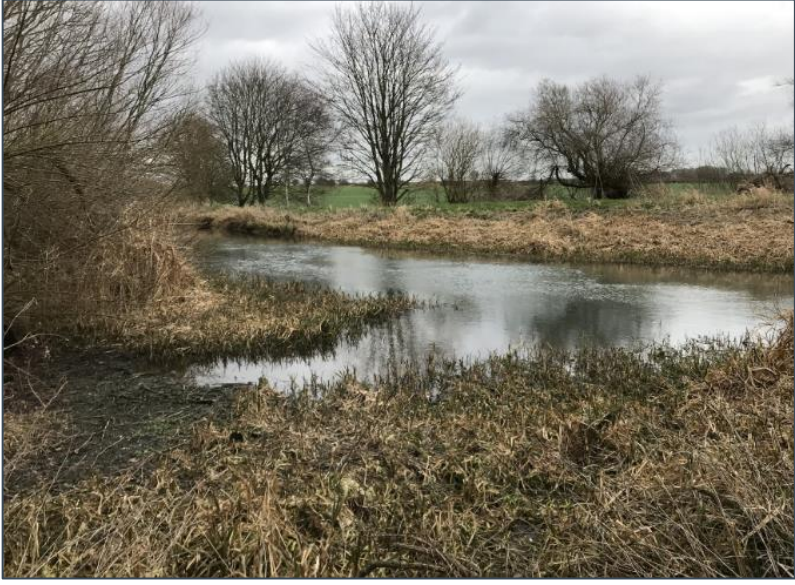
<p data-bbox="395 1305 1072 1337">Plate 16: Wet woodland and backwater on West Beck.</p>
Channel Form	<p data-bbox="395 1384 1390 1556">Within the study area, West Beck is very deep with steep banks and uniform flow conditions (Plate 15). The channel is approximately 15 m wide at the bank top; and 8 m wide at the bank base with a good degree of geomorphological complexity in places, in particular, adjacent to the farm building. The study area is surrounded by arable farming, with flood embankments lining the river (Plate 15).</p>
Substrate Conditions	<p data-bbox="395 1599 1358 1736">Within the study area, the West Beck Lower has a medium gradient and a silty bed with occasional fine and coarse gravel. Bank material is fine grained, dominated by sandy gravelly clay with localised silt. Both banks display a predominantly vegetated graded profile and as stated aligned with flood embankments.</p>

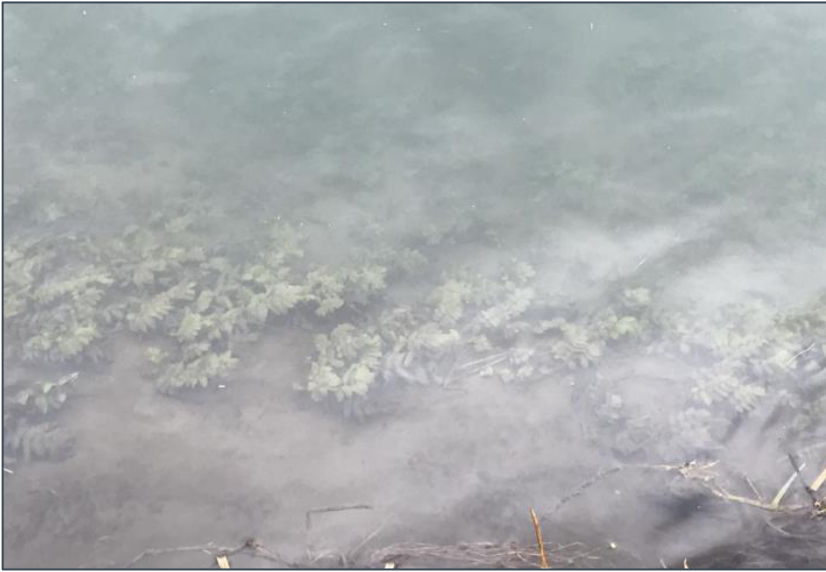
Flow Conditions	<p data-bbox="395 1778 1369 1904">The West Beck study area is characterised by uniform laminar flow, contributing to the settling of fine silts on the bed and overall depositional nature of the study area (Plate 17). Only minor sediment sources were noted along the study area (e.g. bank erosion), suggesting that the majority of the sediment load is derived from the upstream catchment.</p>

<p>Plate 17: Fine Sedimentation on the bed of West Beck.</p>
Floodplain Characteristics	Within the study area, the river is constrained within the flood embankments. As such, limited floodplain connectivity along the river was observed throughout the study area.
In-channel / Riparian Vegetation	The banks and margins are well vegetated with rushes, sedges and reeds. In places emergent aquatic vegetation in the channel was noted, although obscured by silt deposition (Plate 17).
Modifications / Structures	There is no bank protection within the study area, although the river is lined with flood embankments. Upstream of the study area is Cleaves Weir (potentially in place as a fish passage barrier).

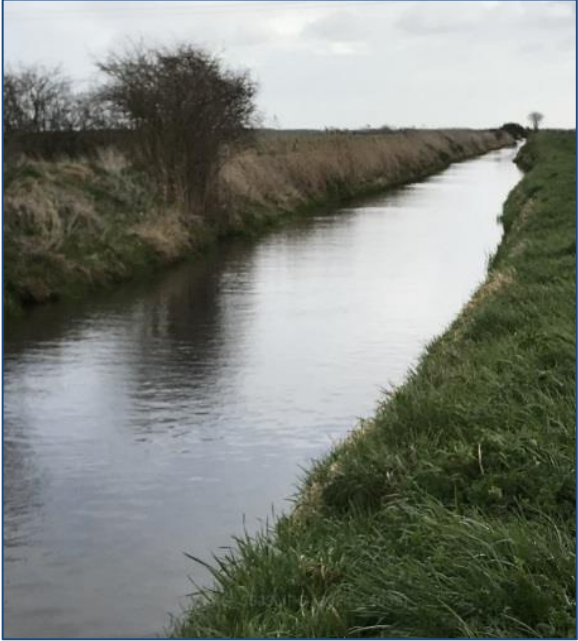
Parameter	Details
<p>Overview</p>	<p>Scurf Dike within the study area is a uniform incised channel that has been artificially straightened and is lined with flood embankments (Plate 18). The channel is dominated by glide flows and silt deposition. No sediment sources were noted along the study area suggesting a dominant source of fine sediments is associated with land and catchment management.</p>

<p>Plate 18: Scurf Dike.</p>
<p>Channel Form</p>	<p>The channel has a straight planform and uniform channel with a flat bed. The banks are relatively steep, approximately 0.7 m high, stable and well vegetated in places throughout the study area. The channel is approximately 7 m – 10 m wide at the bank top, and 6 m wide at the bank base. Both banks are aligned with flood embankments (Plate 18 and Plate 19). The channel within the study area appears to be of a typical sediment deposition zone, with slow flows, low gradients and low velocities contributing to the settling out of fine sediments / silts along a flat bed, with limited geomorphological complexity (Plate 19).</p>

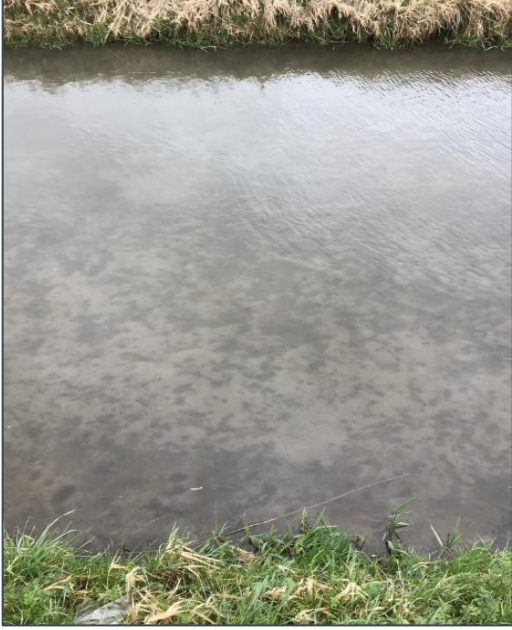
<p data-bbox="395 972 976 1003">Plate 19: Fine siltation on the bed of Scurf Dike.</p>
Substrate Conditions	<p data-bbox="395 1043 1382 1218">The substrate is dominated by sands and silts. Although silts / fine sediments are the main substrate material overlying the sands, the water was generally clear at the time of the walkover survey, despite this high silt content. No sediment sources were noted along the study area, suggesting a dominant source of fine sediments is associated with land and catchment management.</p>
Flow Conditions	<p data-bbox="395 1258 1311 1326">The wide, straight uniform channel is characterised by low energy glide flows, which were observed throughout the study area, with limited flow diversity or in channel features.</p>
Floodplain Characteristics	<p data-bbox="395 1361 1299 1429">Scurf Dike appears to be constrained within the flood embankments and as such, limited floodplain connectivity along the beck was observed throughout the study area.</p>

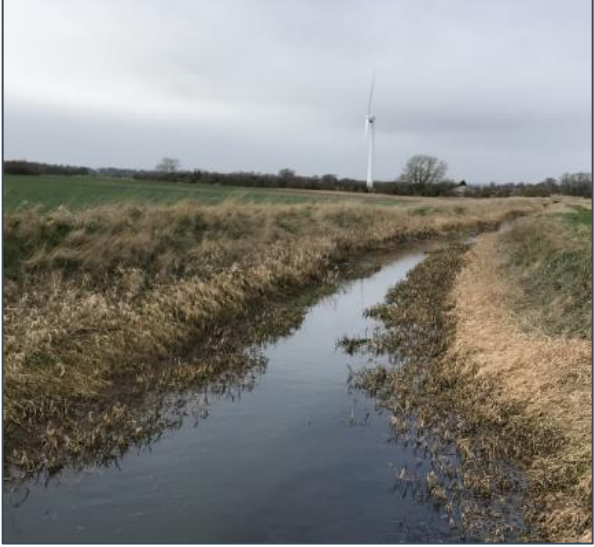
Parameter	Details
Overview	The Watton Beck is approximately 11 km in length with a predominately straight planform. The channel displays limited flow and geomorphological diversity, although in places a two-stage channel is a feature of the Watton Beck (Plate 21). However, overall the Watton Beck within the study area is typical of a modified drainage system, with uniform channel shape and aligned with embankments (Plate 21).

<p data-bbox="395 898 683 925">Plate 21: Watton Beck.</p>
Channel Form	<p data-bbox="395 976 1366 1211">The channel has a straight planform and the banks are relatively steep at approximately 1 m high. They are stable and well vegetated in places throughout the study area. The channel is approximately 7 m – 10 m wide at the bank top, and 5 m wide at the bank base, displaying a two-stage channel in places with a low flow channel and aligned with embankments (Plate 21 and Plate 22). The substrate is dominated by sands and silts and appears to be of a typical sediment deposition zone, with slow flows, low gradients and low velocities contributing to the settling out of fine sediments/silts.</p>

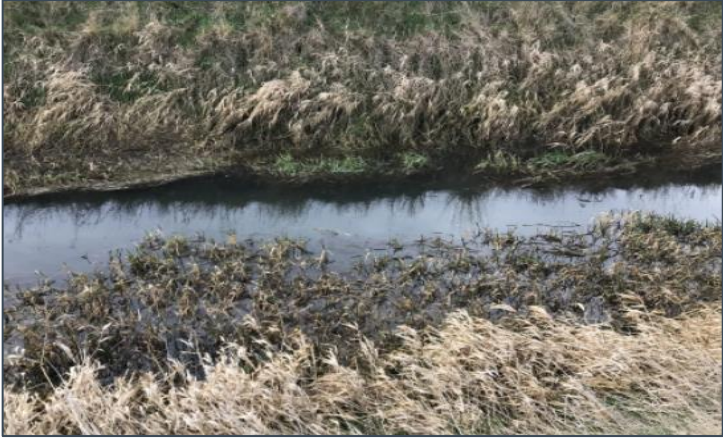
<p data-bbox="395 1727 935 1753">Plate 22: Low flow channel in Watton Beck.</p>
Substrate Conditions	<p data-bbox="395 1805 1374 1859">As stated above, the substrate is dominated by sands and silts. The overall quality of water reflects the high silt content influencing turbidity levels. No sediment sources were noted along</p>

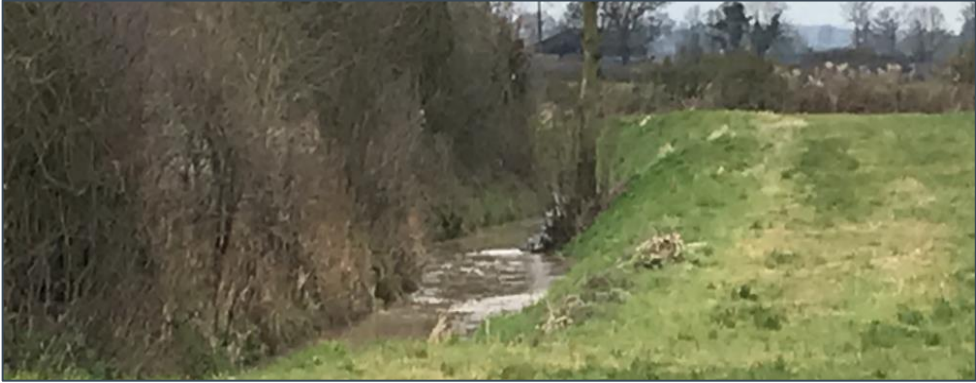
Parameter	Details
Overview	<p>Bryan Mills Beck displays a sinuous planform, although incised adjacent to arable farming in places (Plate 23).</p>

<p>Plate 23: Bryan Mills Beck.</p>
Channel Form	<p>The channel has a sinuous planform and although similar to Gransmoor Drain, the beck is deeply incised, with a 2 m - 3 m bank base, 5 m bank top and steep well vegetated banks up to 2 m in places (Plate 23). The beck does display a variety of in-channel features, such as riffles, bars with variety of geomorphological processes occurring such as deposition and erosion.</p>
Sediment	<p>Substrate is dominated by silts, with a dominant source of fine sediments which appears to be associated with land and catchment management along with exposed banks (as can be observed in Plate 23).</p>
Flow (Habitat) Conditions	<p>The Bryan Mills Beck displays a variety of flow habitats, such as deep riffles and glides.</p>

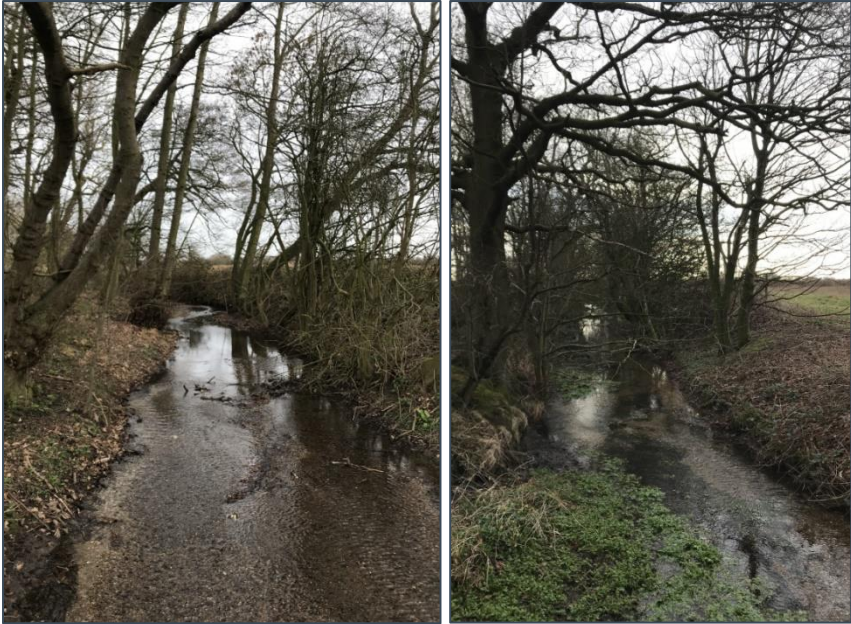
Parameter	Details
Overview	<p>Scarborough Beck is a chalk river approximately 8 km in length with a straight to moderately sinuous planform. The channel displays flow and geomorphological diversity in places. In particular, through Bealey’s Plantation and Lakes Wood which encompass the study area. Springs are a dominant feature in Bealey’s Plantation and Lakes Wood which contribute to the crystal-clear waters flowing through the study area (Plate 24).</p>

<p>Plate 24: Scarborough Beck.</p>

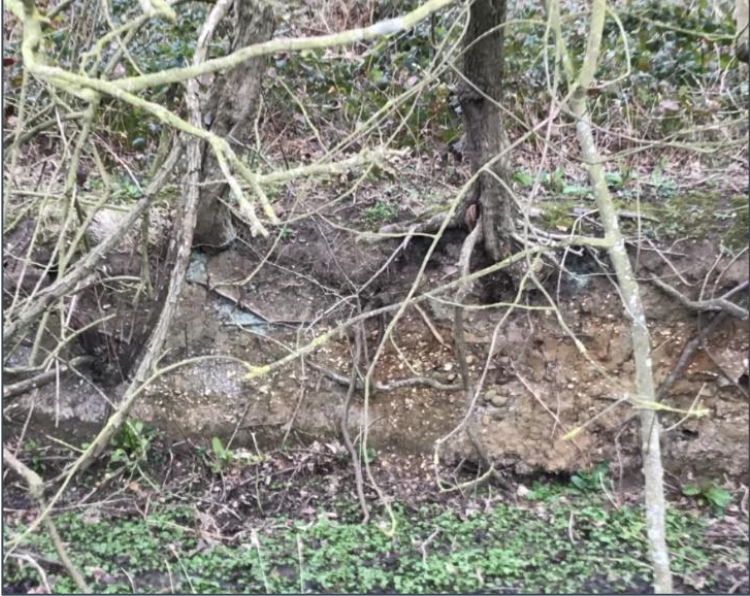
Parameter	Details
Channel Form	<p>The channel has a straight to moderately sinuous planform. The banks are relatively shallow, approximately 0.5 m to 1 m high, stable and well vegetated in places throughout the study area. The channel is approximately 5 m to 7 m wide at the bank top, and 3 m to 5 m wide at the bank base, displaying diversity in the channel width-depth ratio of the Scarborough Beck. The substrate is dominated by sands, gravels and organic matter with only localised deposits of silts noted at low flow velocity zones, such as the channel margins and in the lee of emergent aquatic vegetation. This was predominately associated with tree roots undercutting the banks, and local bank erosion during high flows (Plate 25).</p>

<p>Plate 25: Localised bank erosion on Scarborough Beck.</p>

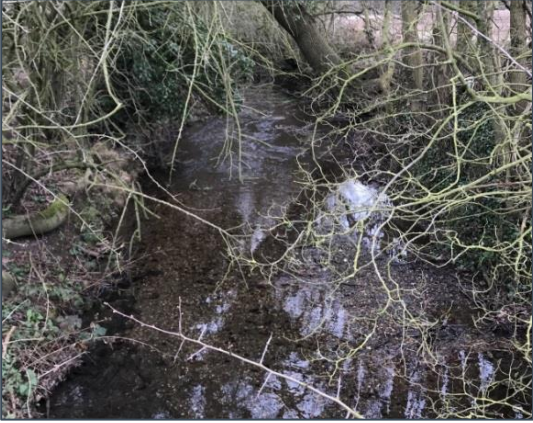
Parameter	Details
	<p>The Scarborough Beck within the study area is influenced by a north-south running field drain, which is narrow and well vegetated in places, with steep, uniform banks and overall trapezoidal shape. The drain contained water at the time of the fluvial walkover, although does not appear to support regular flows (Plate 26)</p>   <p>Plate 26: Field drain connected to Scarborough Beck.</p>
<p>Substrate Conditions</p>	<p>As stated above, the substrate is dominated by sands, gravels and organic matter. The clear water reflects the spring fed Scarborough Beck within the study area and the low sediment yield from the surrounding catchment.</p>
<p>Flow Conditions</p>	<p>Flows are dominated by low energy glides and riffles, providing good flow diversity along the Scarborough Beck within the study area (Plate 27).</p>

<p>Plate 27: Evidence of flow diversity within Scarborough Beck.</p>
