Environmental Statement: Volume 5, Annex 2.2 - Water Framework Directive Assessment

Hornsea Project Three

Offshore Wind Farm

Annex 2.2 – Water Framework Directive Assessment

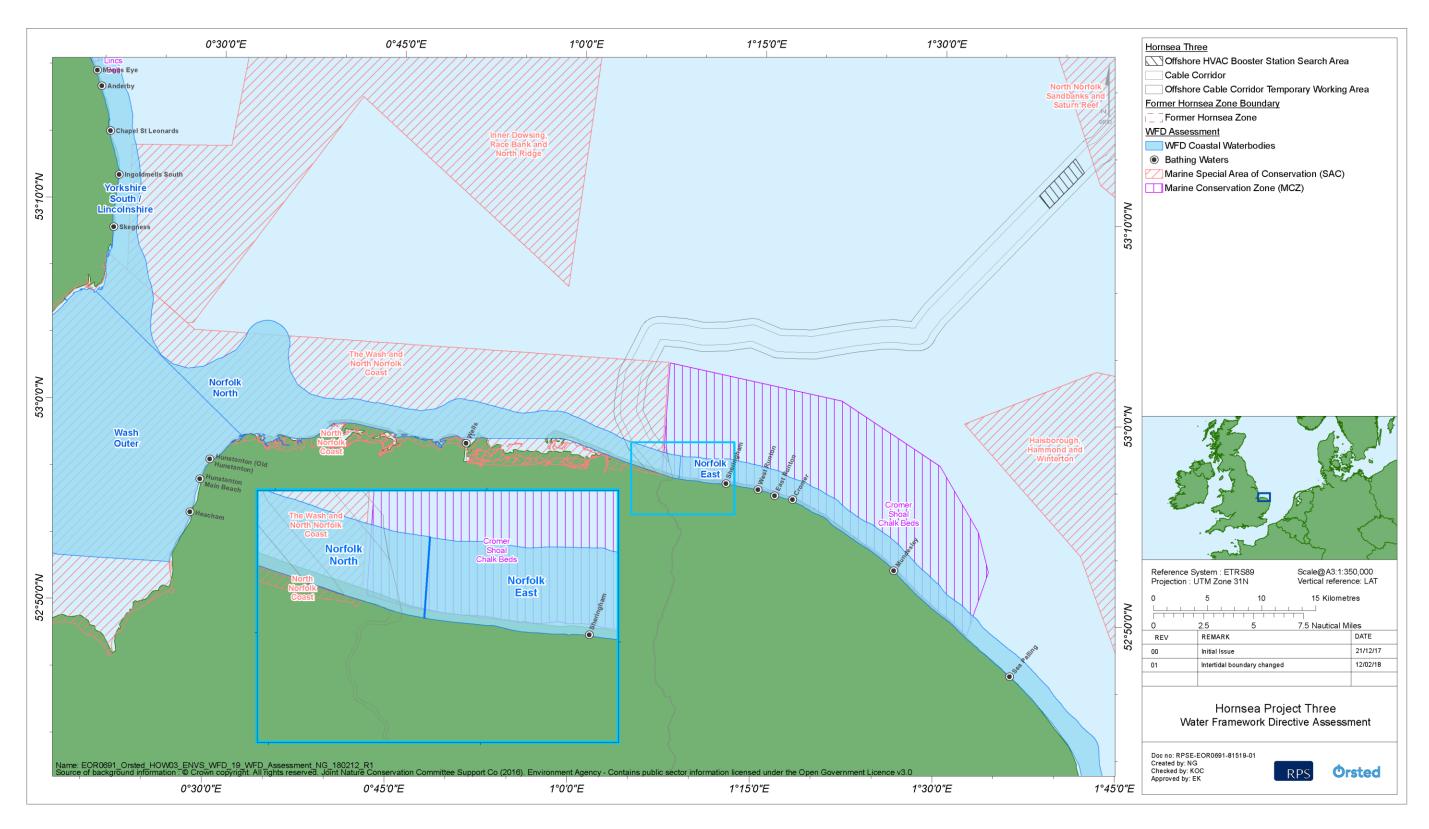
Figure 1.1: Location of Hornsea Three offshore cable corridor and intertidal area (inset) in relation to WFD Coastal Water Bodies, Bathing Waters and Protected Areas.

- 1.2.1.2 Export cables are used for the transfer of power from the offshore substations to the onshore high voltage alternating current (HVAC)/high voltage direct current (HVDC) substation. Up to six export cables will be required for Hornsea Three. The offshore export cables shall be located within the Hornsea Three offshore cable corridor and make landfall near Weybourne Hope on the north Norfolk coast. The maximum design envelope for the Hornsea Three offshore cable corridor and the intertidal area are set out in volume 1, chapter 3: Project Description. The exact location and orientation of the Hornsea Three offshore cable corridor and intertidal shall be determined during an iterative route planning process following the granting of the DCO. The offshore cables will be located wholly within the Hornsea Three offshore cable corridor shown in Figure 1.1.

- 3.2.2.1 The nearest Natura 2000 sites of relevance to the Norfolk North coastal water body are the Wash and North Norfolk Coast SAC and the Norfolk Coast SAC/SPA (see Figure 1.1). The Hornsea Three offshore cable corridor is located within both of these Natura 2000 sites at the landfall area. The Hornsea Three offshore cable corridor also overlaps with the Cromer Shoal Chalk Beds Marine Conservation Zone (MCZ) which is rated as being in favourable condition.
- 3.2.2.2 The 2015 Anglian RBMP also lists a number of Bathing Waters and designated waters under the Bathing Water Directive, all of which are located outside the Hornsea Three offshore cable corridor. Therefore, only the Wash and North Norfolk Coast SAC and the Norfolk Coast SAC/SPA and the Cromer Shoal Chalk Beds MCZ are proposed for inclusion in the Scoping.
