Appendix 16-1 - Road Safety Audit

Stage 1 Road Safety Audit

Cloghercor Wind Farm, Co Donegal

February 2023

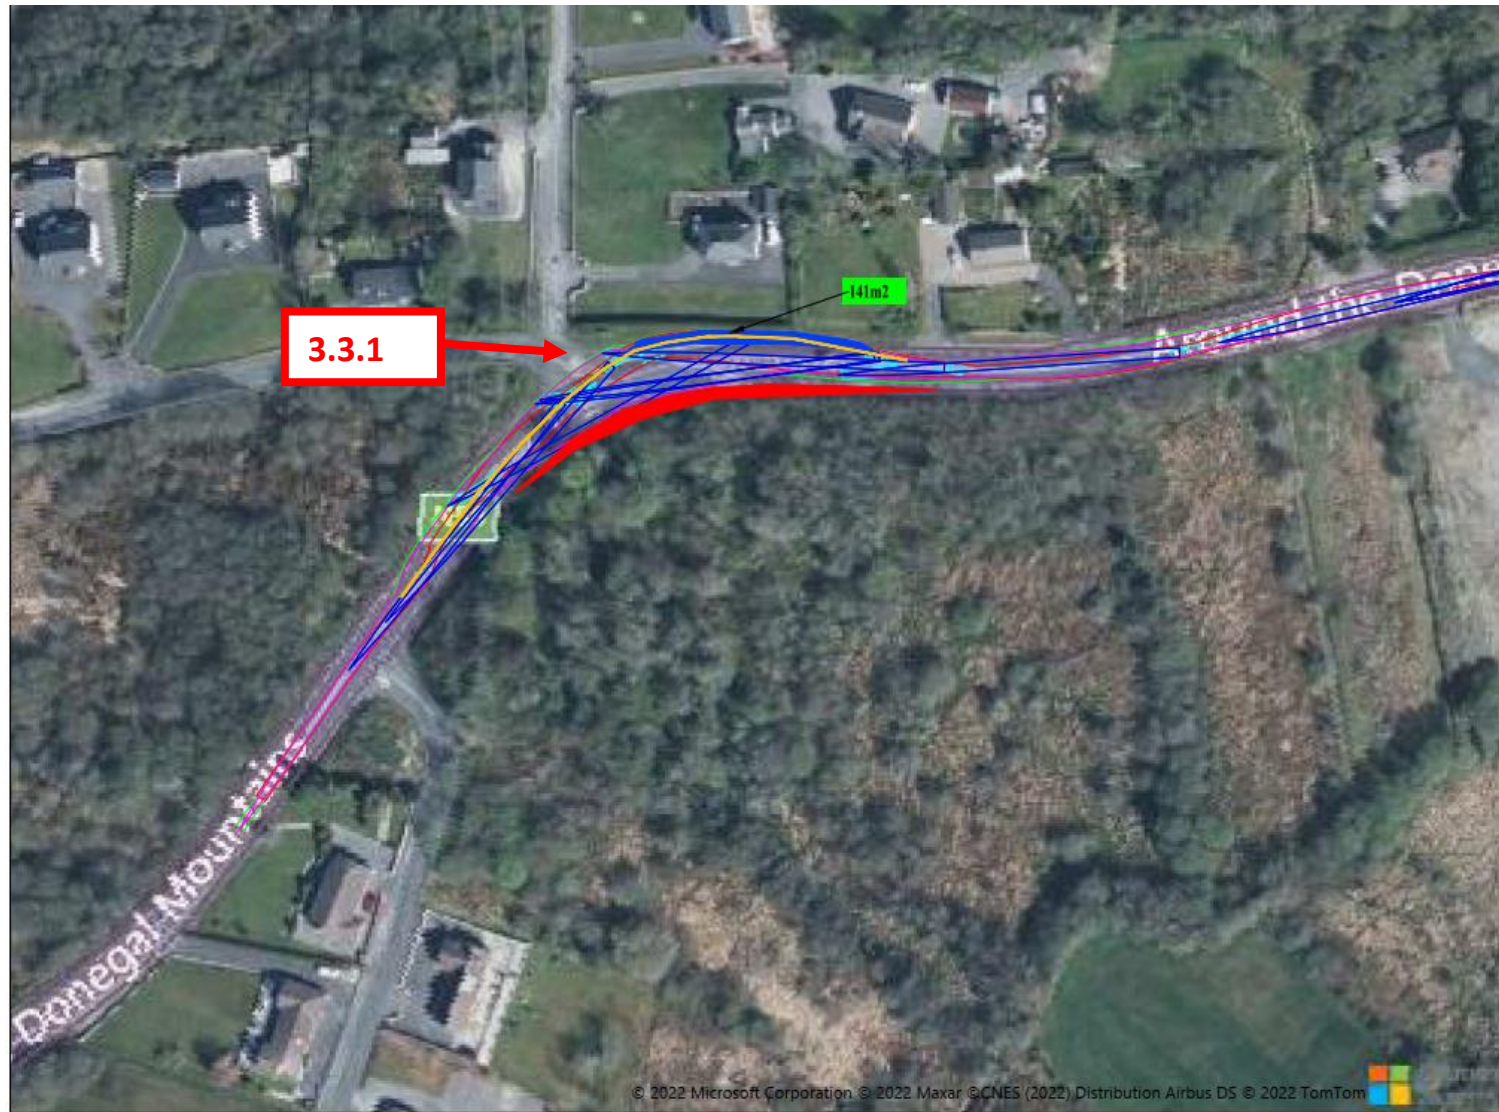
Fig 16.8 B

3.3.1 Road Widening Fig 16.8

Hazard: The removal of this verge / replacement with hardstanding may result in overshoot type collisions with National Road traffic.

Recommendation: Ensure adequate physical measures are retained / installed to ensure local road traffic both yield to the national Road users and also at a suitable angle, where approaching vehicles from both direction can be observed with ease.

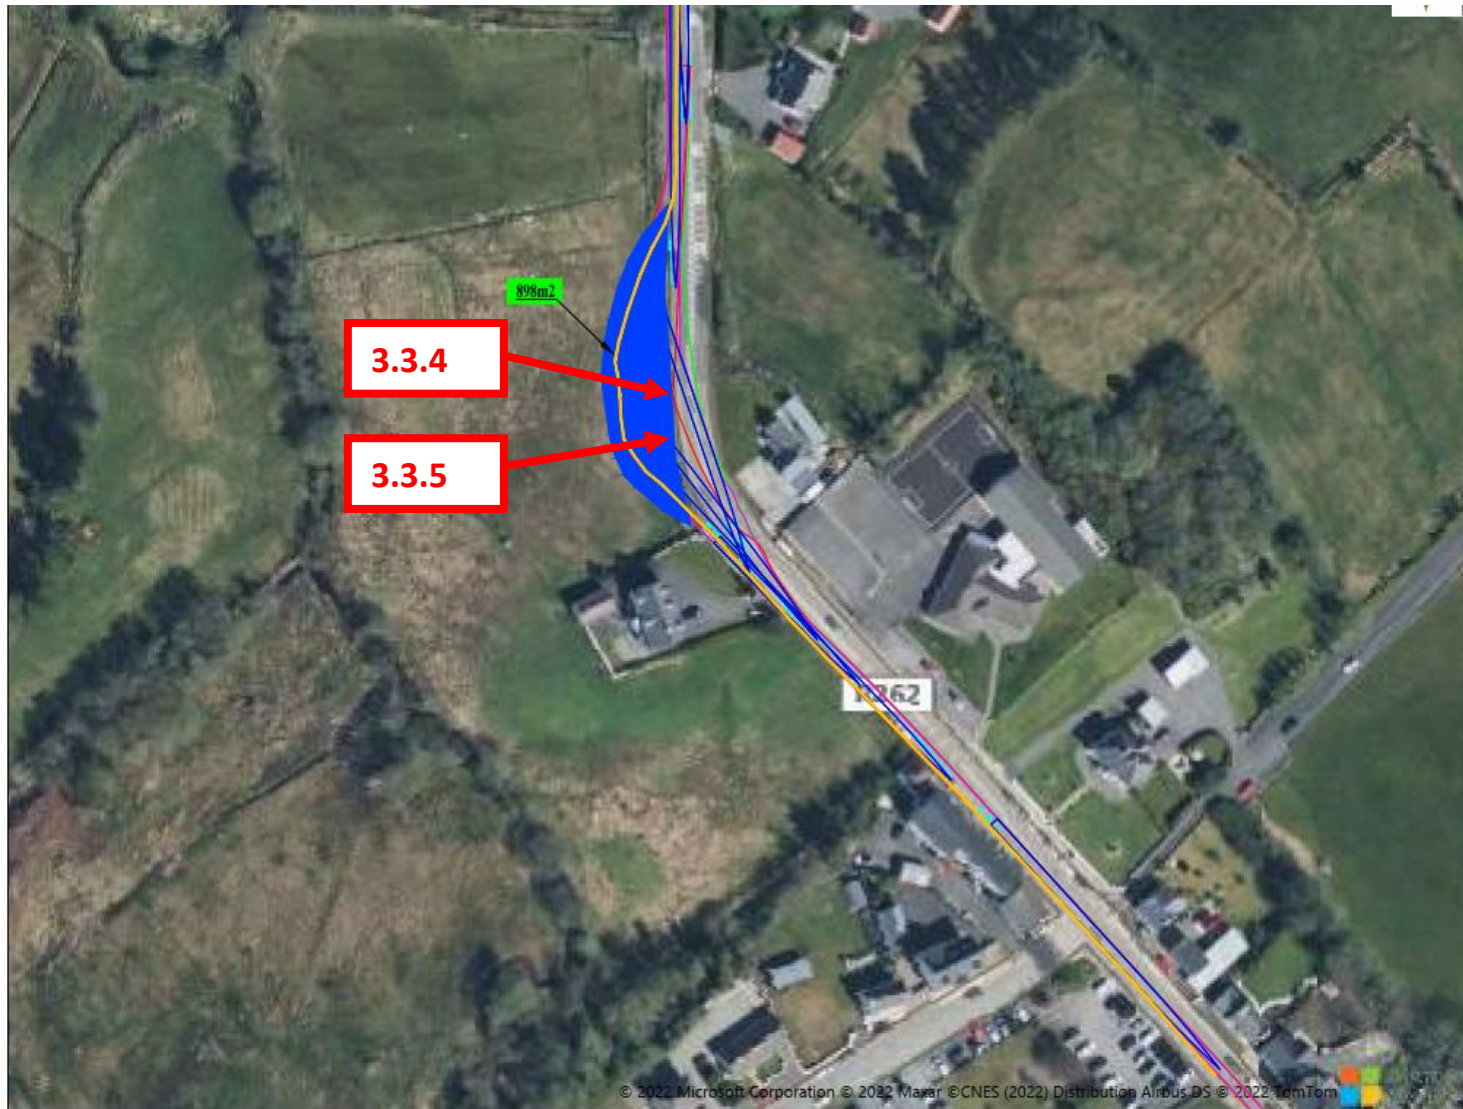
Sheet: B
Drawing No: Fig 16.15

3.3.4 Road Widening Fig 16.15 - VRS

Hazard: Errant motorist may traverse the road widening and overturn on the steep gradient.

3.3.5 Road widening Fig 16.15 – Signage

Hazard: Users may attempt to drive around the bend at excessive speed. Loss of control collisions may result.

Recommendation: Ensure suitable vehicle restraints are provided wherever the gradient is within the carriageway clear zone. Furthermore, ensure the anticipated angle of impact is suitable for the performance of the barrier.

Recommendation: Ensure suitable warning of the bend is provided to the road user at all times, even when component deliveries are scheduled.
